# ELECTRICAL ADJUSTMENTS

<u>CONTENTS</u>	Page
Electrical connections.....	2
Start up the crane .....	2
Erection condition .....	3
Trolley radius and limit setting .....	6
Minimum trolley radius .....	7
Maximum trolley radius.....	8
Hoist limit settings.....	9
Hook height limit .....	10
Hoist depth limit.....	11
Wire part selection.....	12
Load/Moment settings.....	13
Load settings .....	14
Hoist zero load setting .....	15
Hoist maximum load setting .....	16
Moment .....	17
110% overload .....	17
Slew encoder deactivation/activation .....	18
Slew limits .....	19
Slew limit settings.....	20
Zone setting.....	21
Service .....	23
Alarm/event buffer.....	24
Hour counters .....	24
Joystick signals .....	25
Wind speed configuration .....	26
Set time & date.....	26
Display brightness.....	27
Flood light switch.....	27
Max. speed .....	28
Data Logging .....	29

## **Electrical connections**

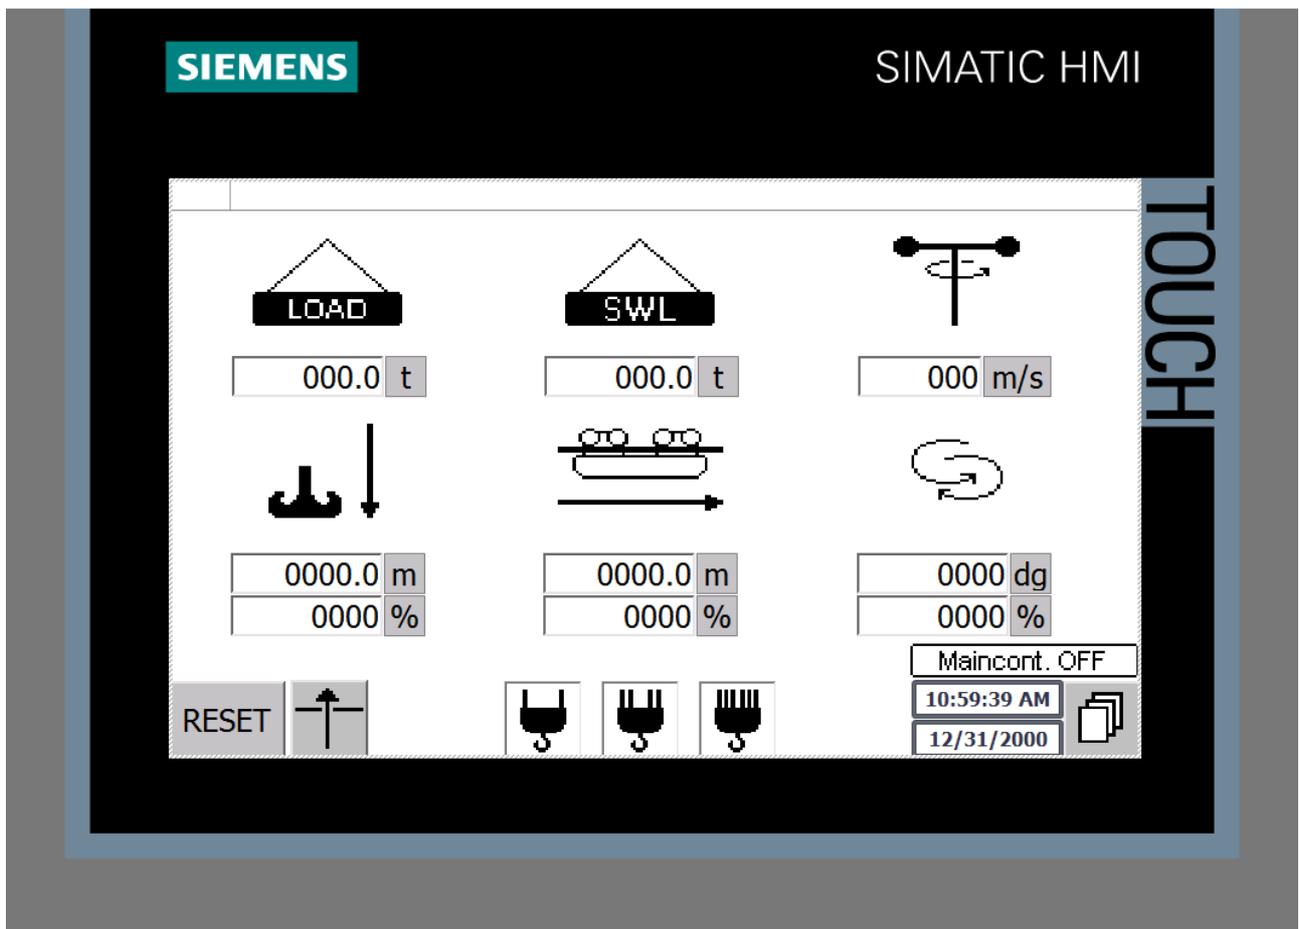
- Press the change page button on the screen display

Status screen

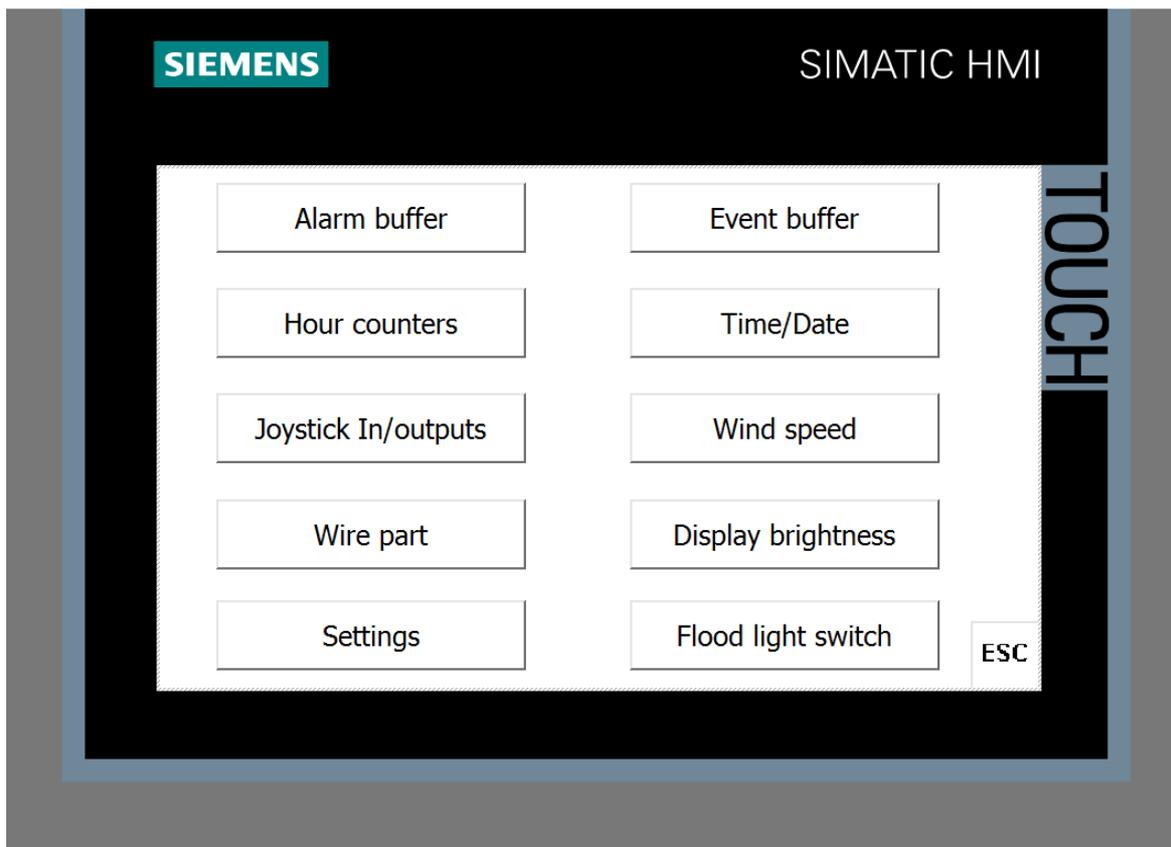
- Press on the Settings button.

NOTE: The setting button will only be visible when the Erection key in the electrical panel is activated.

Select screen

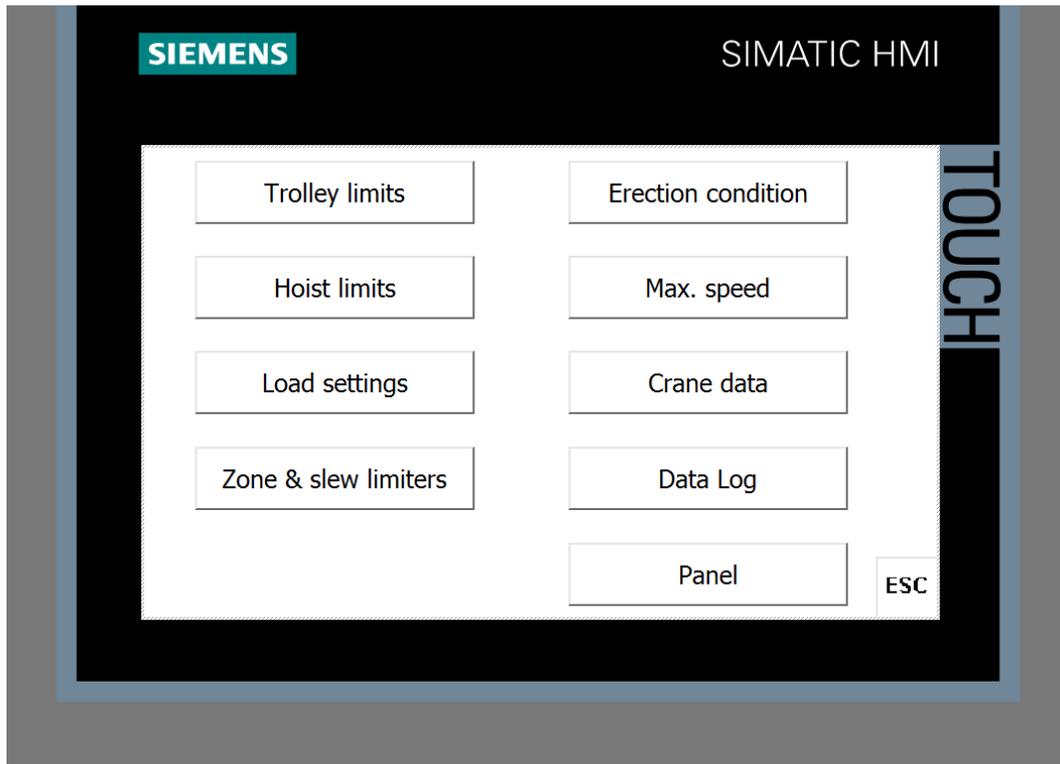
- Press on the Username window and a keyboard will appear on the screen
- Enter Username: KROLL - ↵
- Press on the Password window and the keyboard will appear on the screen again
- Enter password: 7400 - ↵
- Press OK
- Now press the Settings button again
- A new page will appear on the screen, here press the Erection condition button

Setting screen

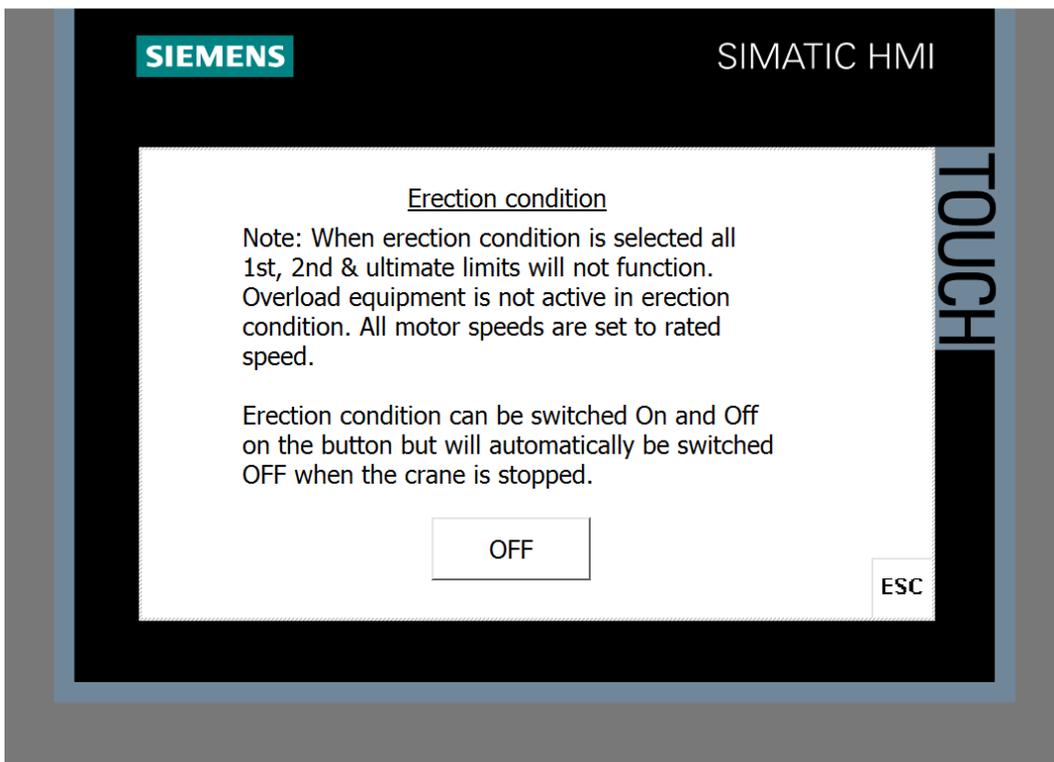
Press the OFF button to select Erection condition and the button will automatically change to ON

Erection condition screen

Now Erection condition is selected and the overload equipment and all limits are cut out.

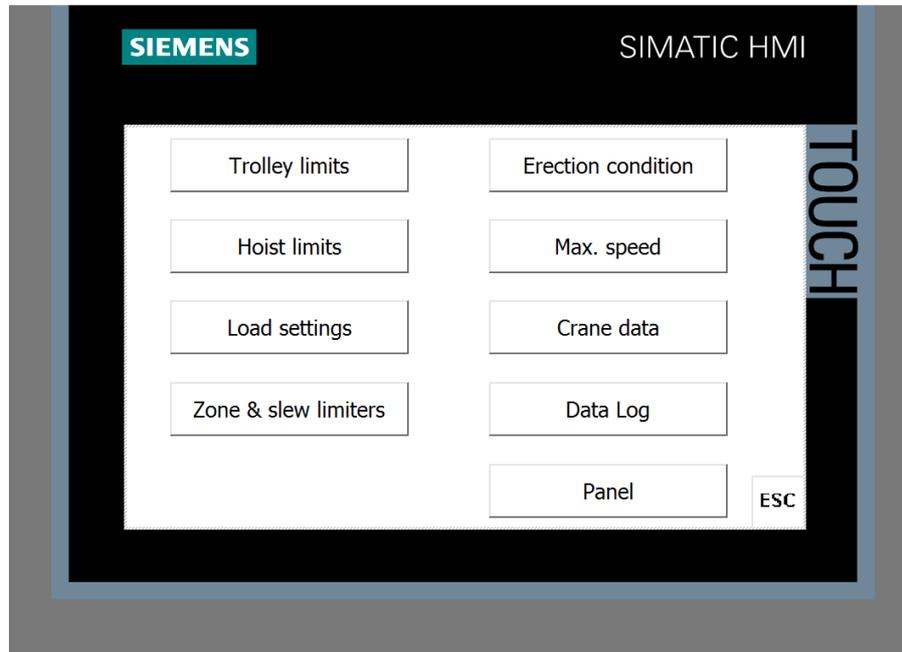
- To set the trolley radius indicator “Jib settings” button on the screen under the Setting menu

Setting screen

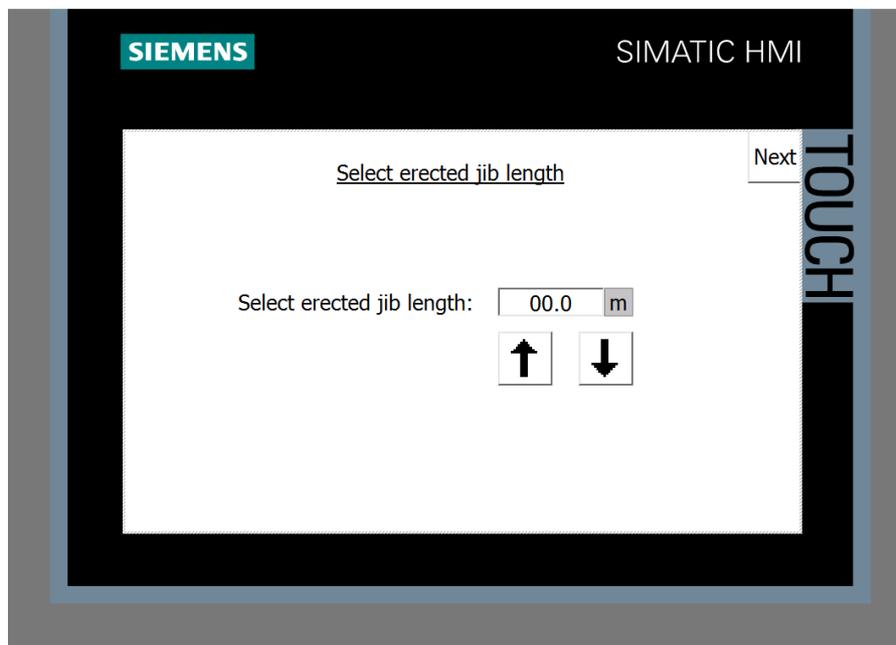
- Select erected jib length and press the “Next” button

Jib selection screen

**Note:** The jib selection is very important. This function also selects the correct load diagram for the erected jib configuration.

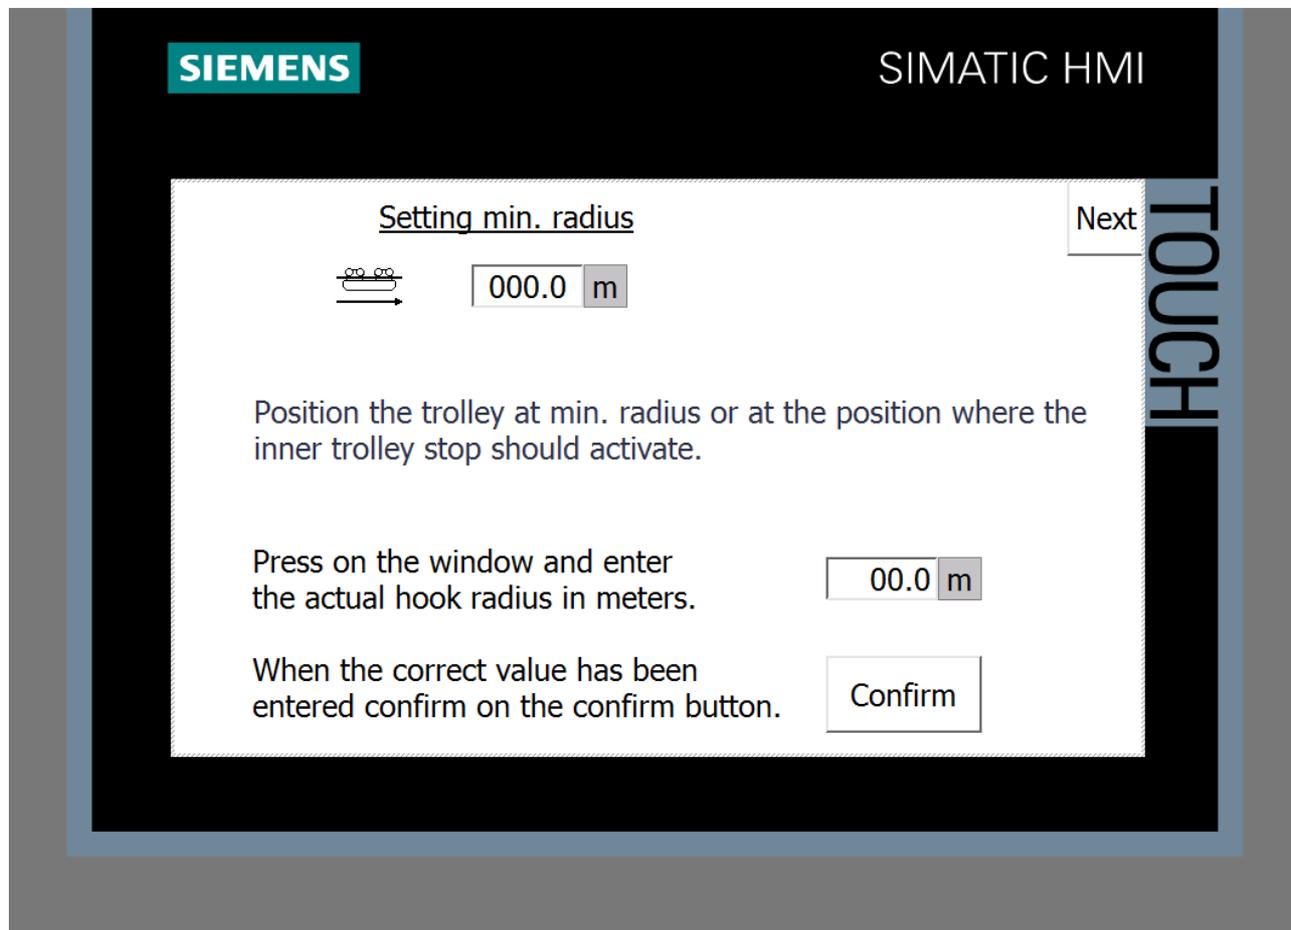
Minimum radius setting screen

- Park the trolley at minimum hook radius measured out, on the ground, from the centre of the mast to the hook
- Press on the radius indicator window and a keyboard appears on the screen. Type in the minimum radius of the hook.
- When the correct radius value has been entered press the "Confirm" button.
- Press the Next button and the screen for setting the maximum radius and outer trolley limit appears on the display

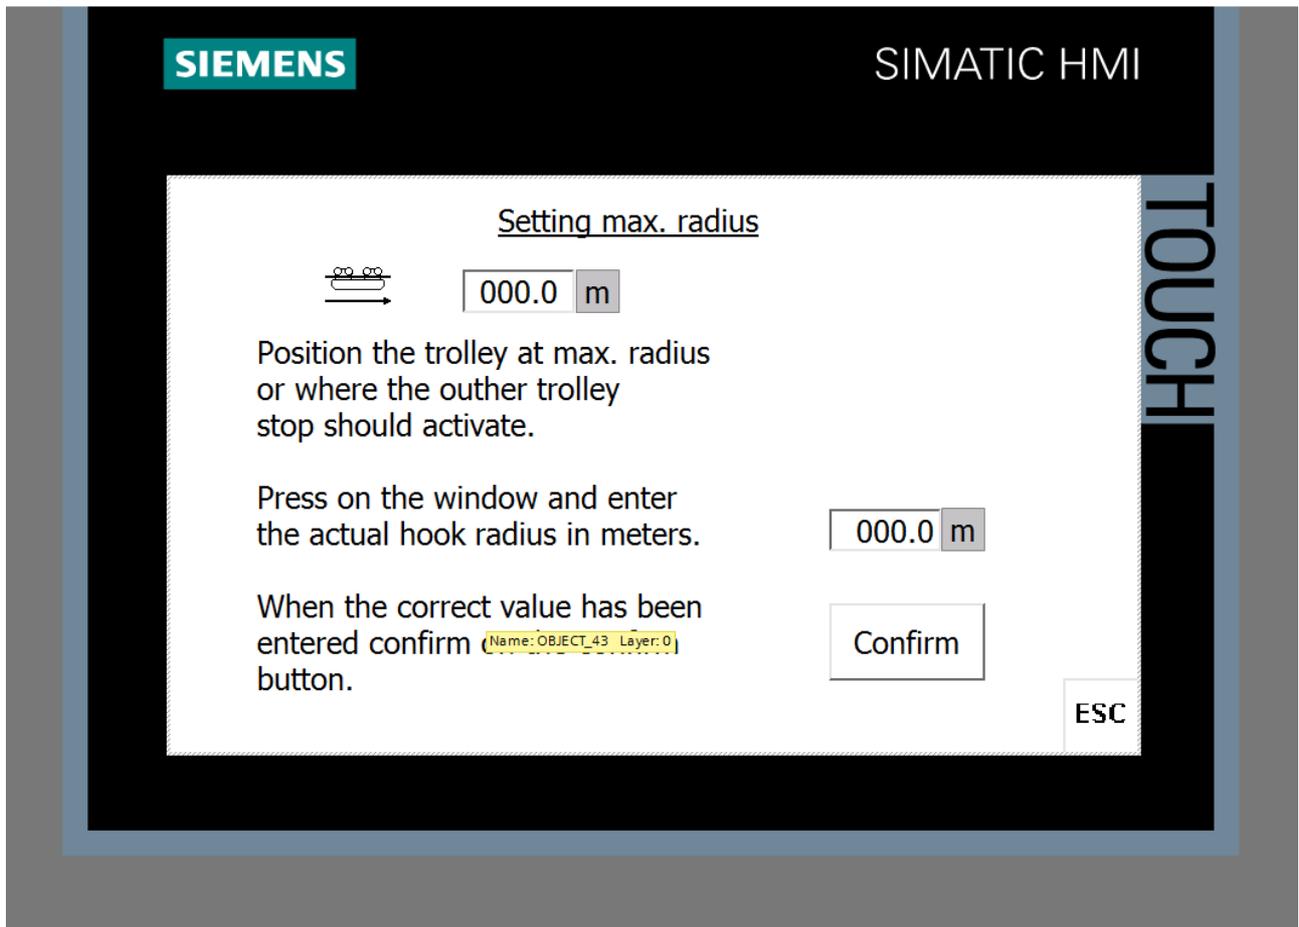
Maximum radius setting screen

- Park the trolley at the maximum hook radius.
- Press on the radius indicator window and a keyboard appears on the screen.
- Enter the actual max. radius value and press the "Confirm" button.
- Press the ESC button and the trolley radius is completed.

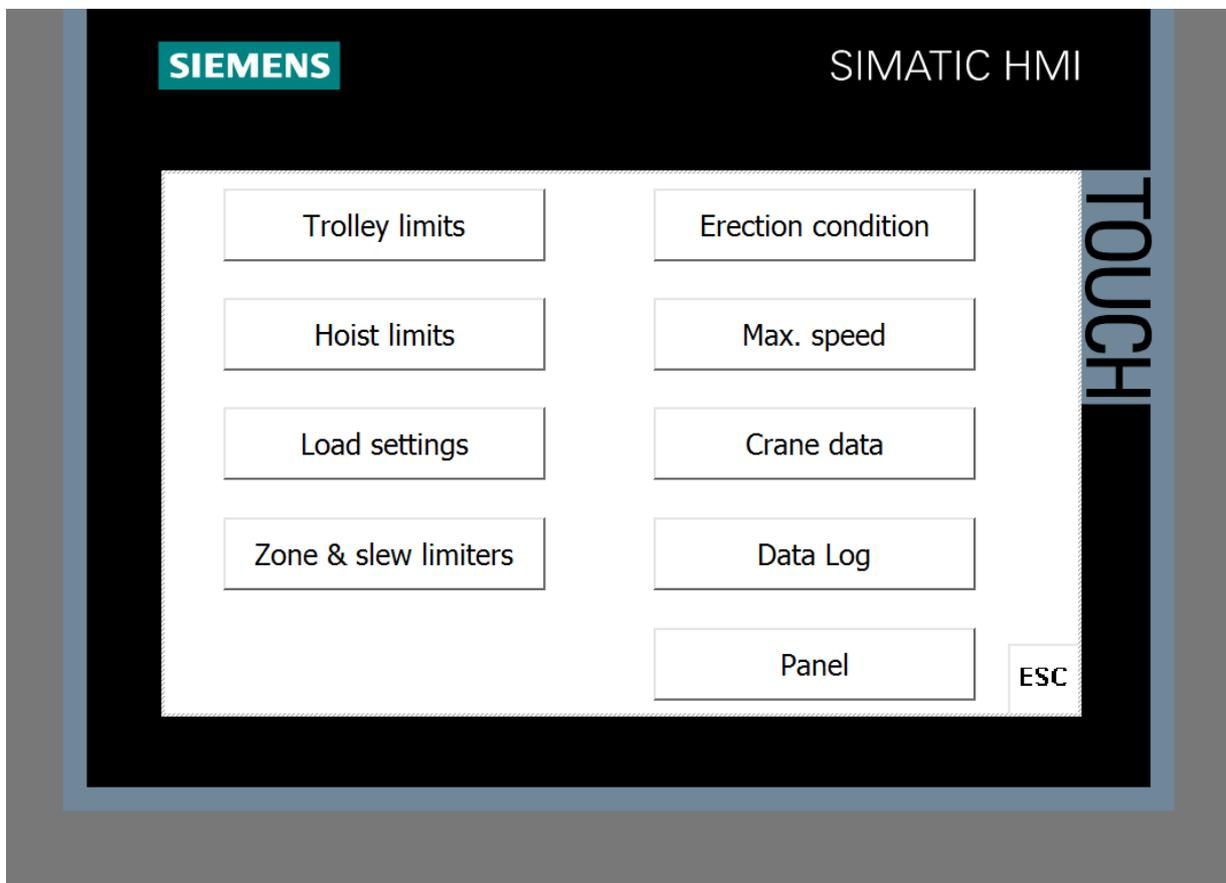
- To set the software hoist limit press the “Hoist limit” button on the screen under the Setting menu

Setting screen

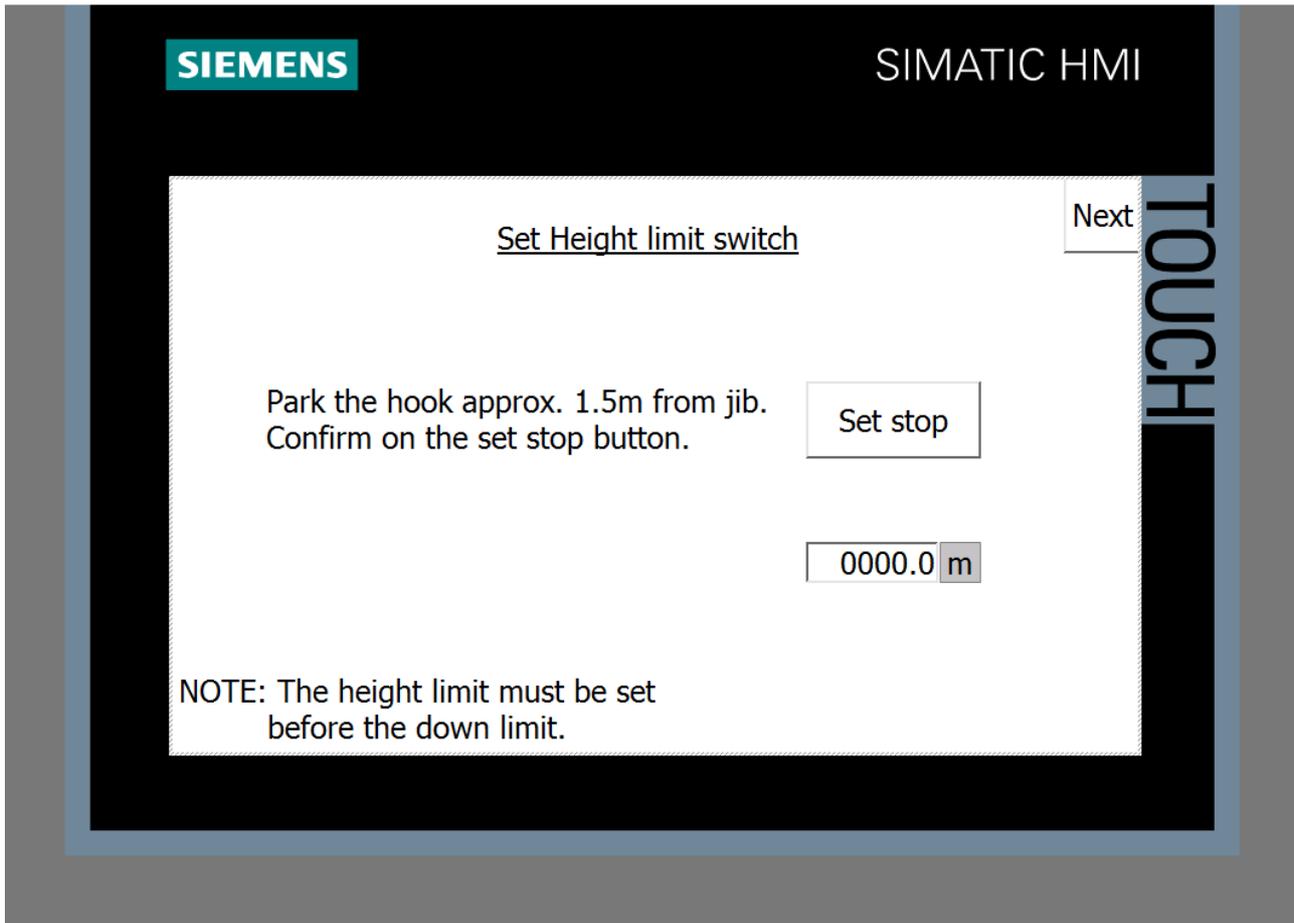
- Move the hook down, approx. 1.5m from the boom.
- Set the software height limit at this position by pressing the “Set stop” button in the display.
- The indicator window should now read “0.0”
- Now the 1st and 2nd height limit is set

Height limit setting screen

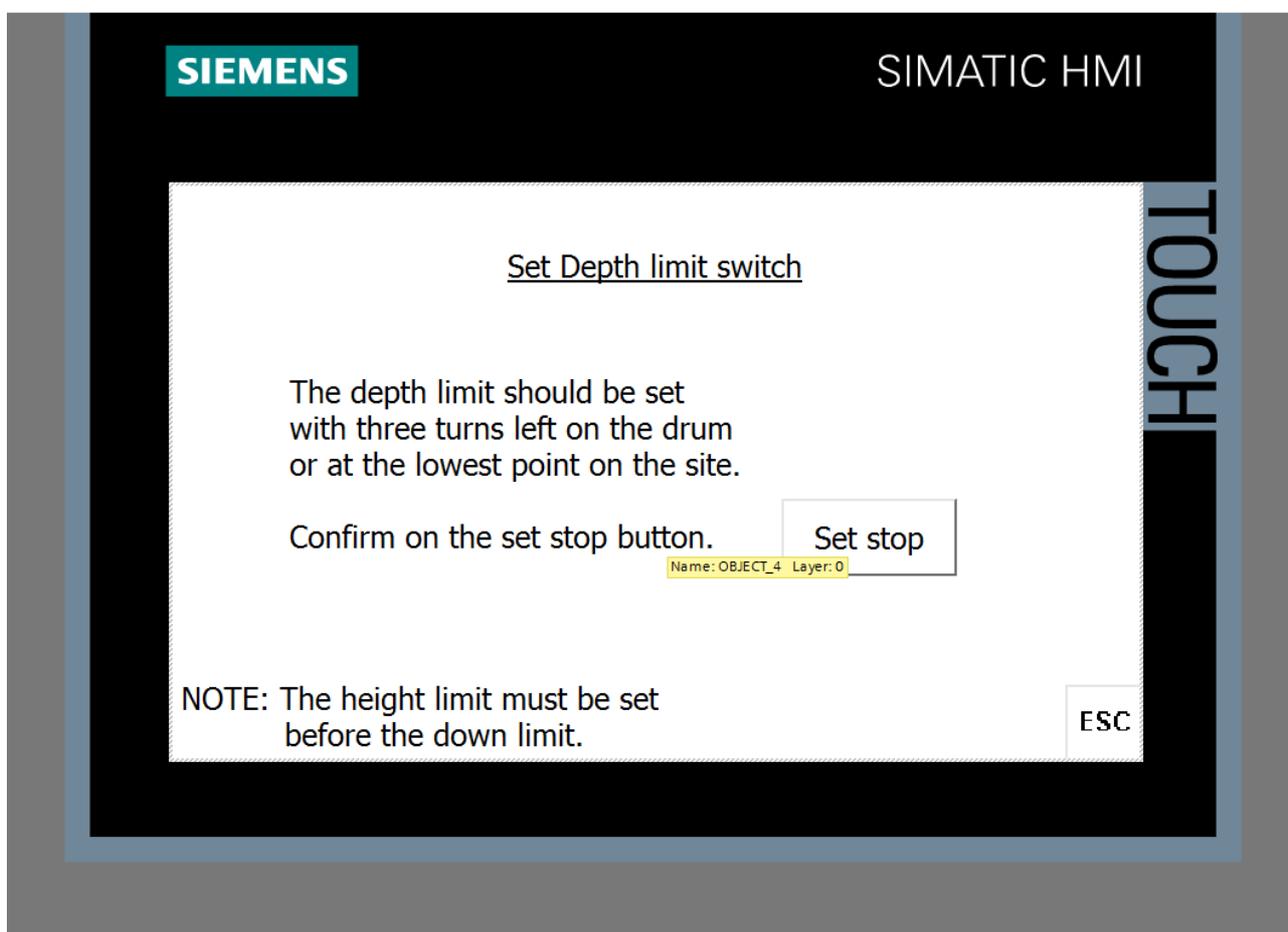
- The depth limit should be set with three turns left on the drum, to prevent the hoist rope from spooling off the drum. The depth limit can also be set as a working limit at the lowest point on the site – if at this position, there are three turns left on the drum.
- Park the main hook at the position where the depth limit is to be set. Press the “Set stop” button on the display.
- Now the 1st and 2nd depth limit is set
- Park the hook approx. 1m lower than the 2nd depth stop (can only be done in erection mode). Here adjust the ultimate limit down switch.

Depth limit setting screen

- If the depth limit is to be set with 3 turns left on the drum then note that the main hoist rope may be longer than the height of the crane. Therefore make sure to un-spool the excess rope on a clean surface to avoid dirt on the main hoist wire. This will shorten the wire rope's lifespan.

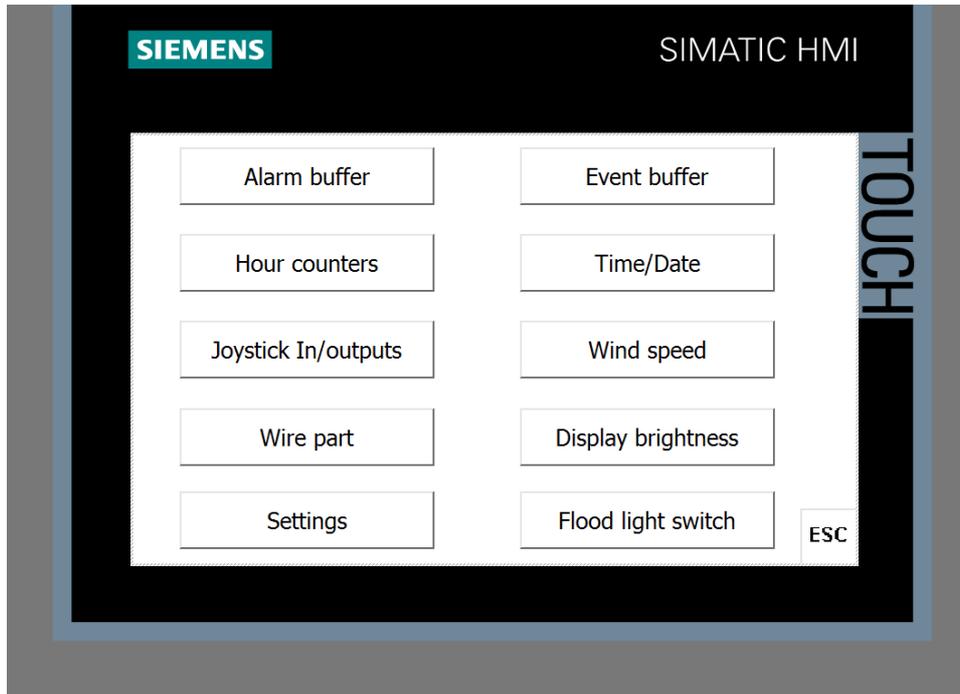
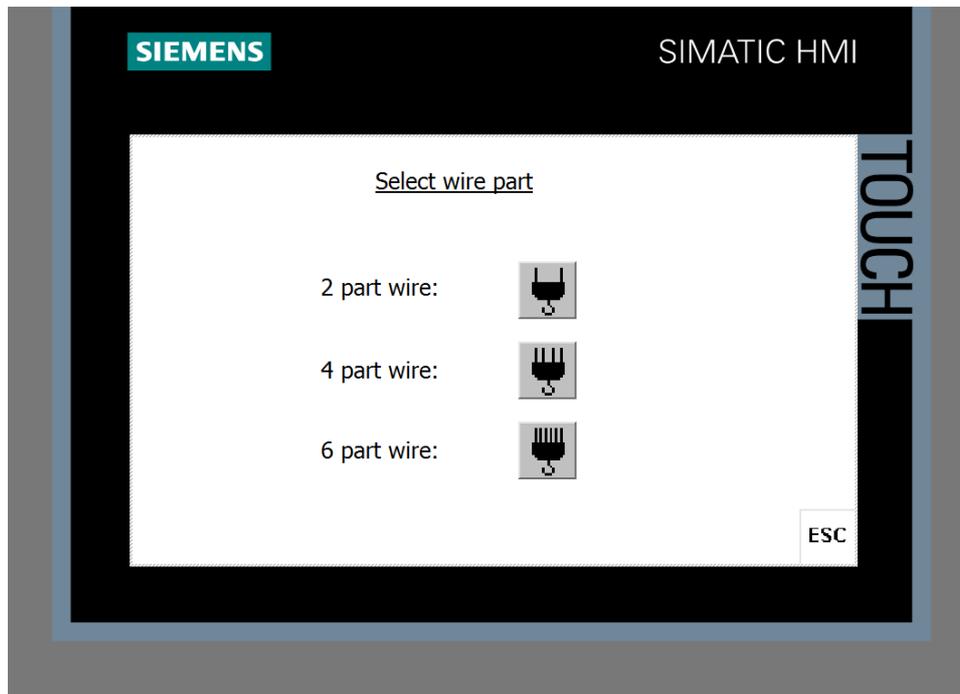
The wire part indicator in the status screen must correspond to the actual wire part the crane is operating with. If not press the “Wire part” button in the Select screen and select the correct wire part configuration. The selected wire part will be hi-lighted green in the status screen.

Wire part selection screen

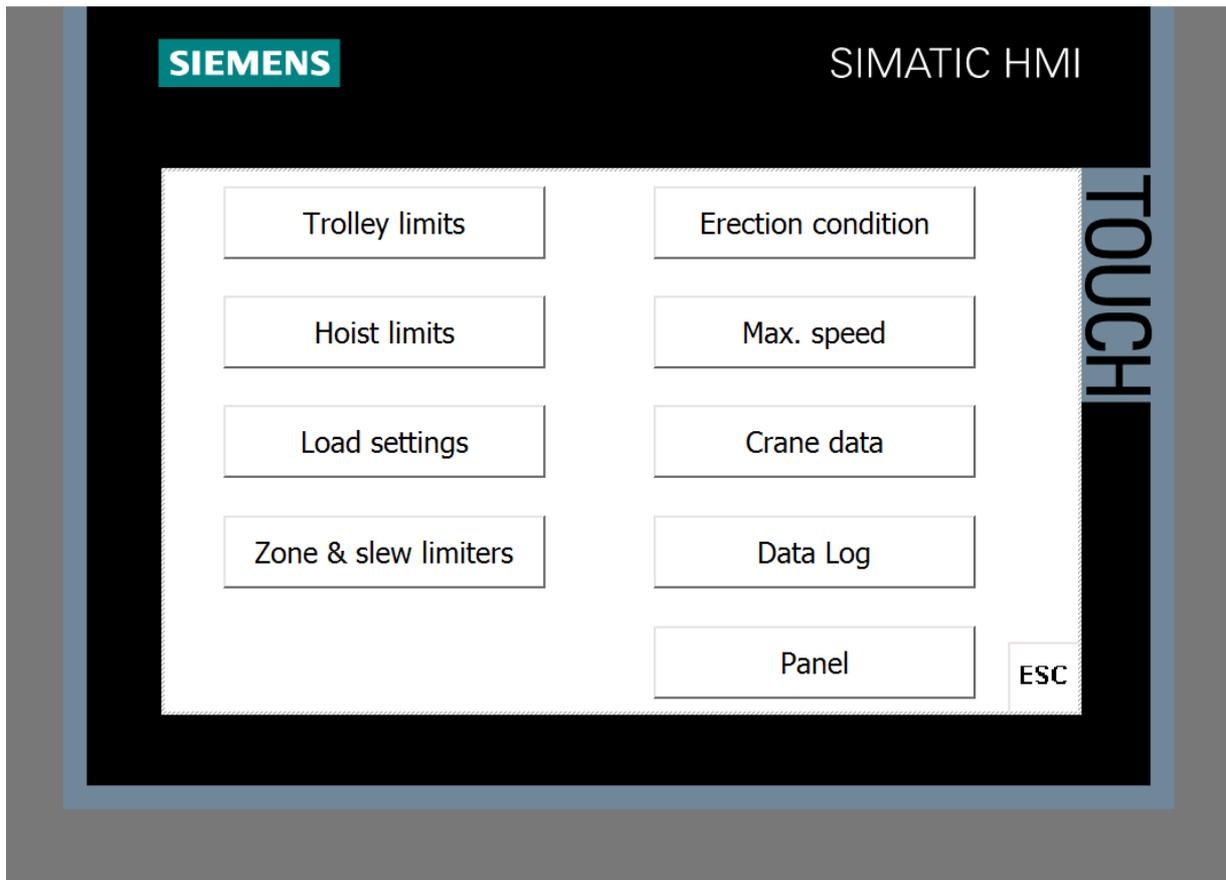
- To set the overload equipment press the "Load setting" button on the screen under the Setting menu

Setting screen

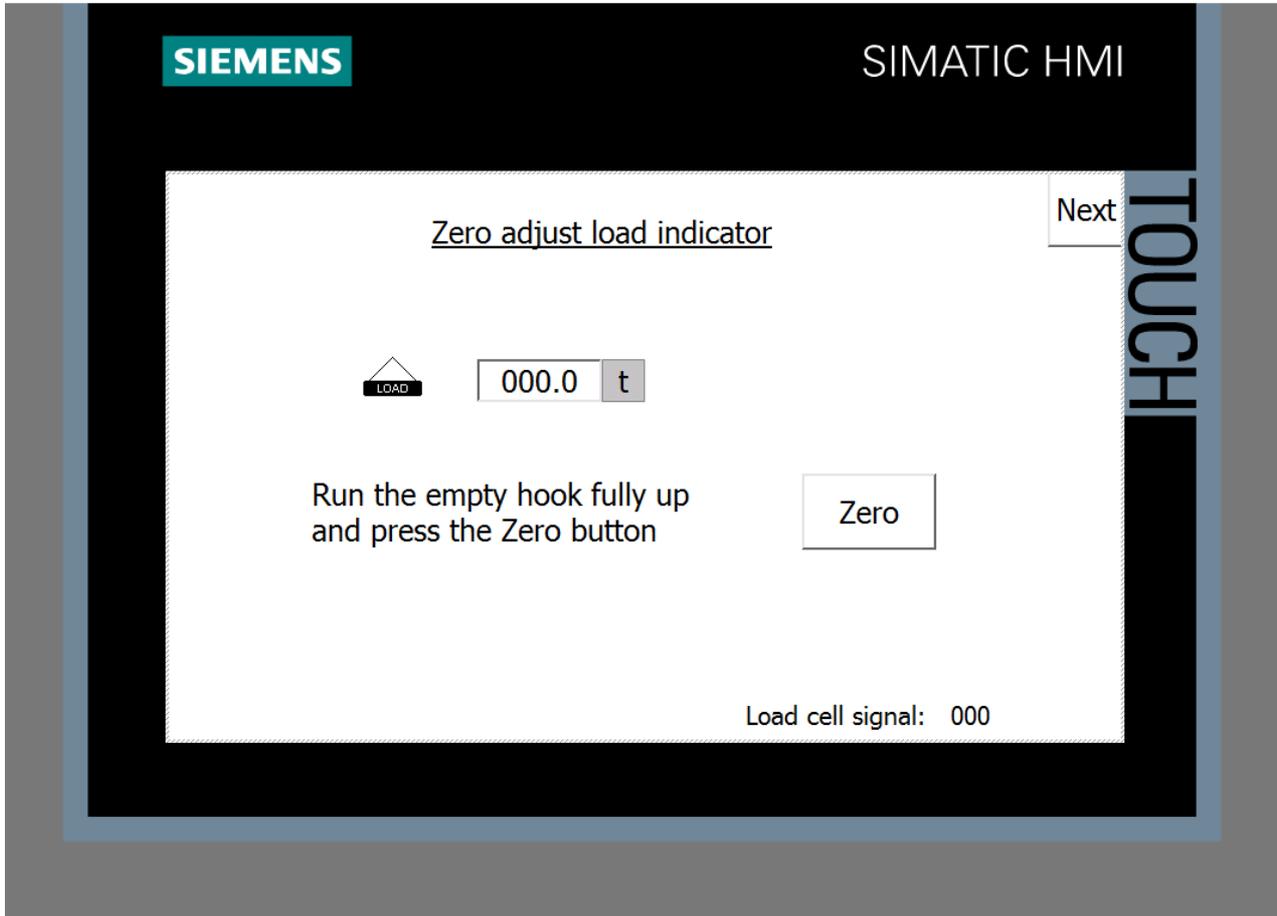
Hoist zero load setting screen

- To zero adjust the load indicator run the empty hook fully up to the height limit and press the “Zero” button. The load indicator will be reset to zero

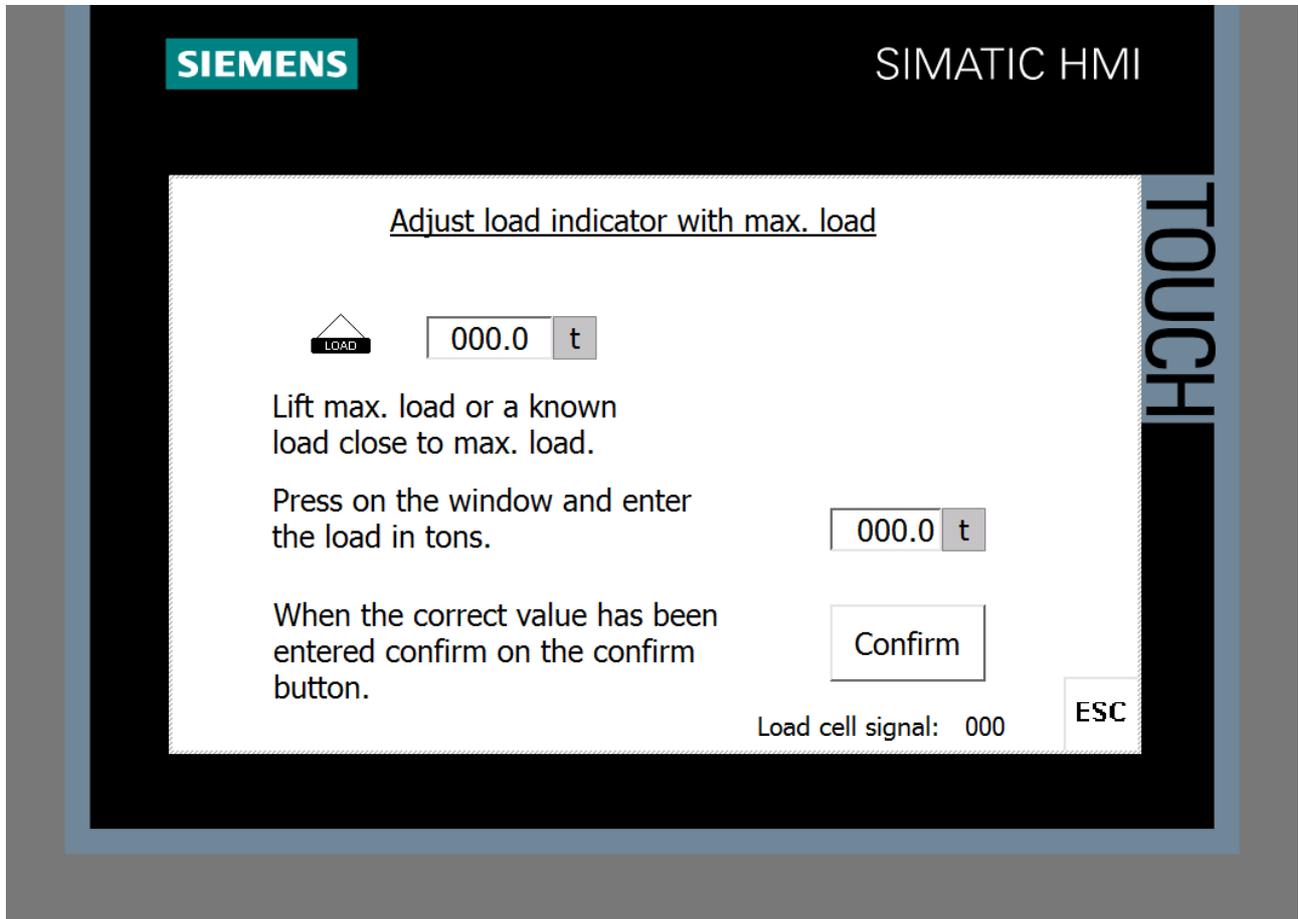
Main hoist load setting screen

- Lift a load close to maximum load (min. 70% of max. load)
- Let the crane rest and then press on the indicator window and a keyboard appears on the screen. Type in the actual load on the hook.
- When the correct value has been entered press the “Confirm” button. The overload equipment has now been calibrated.

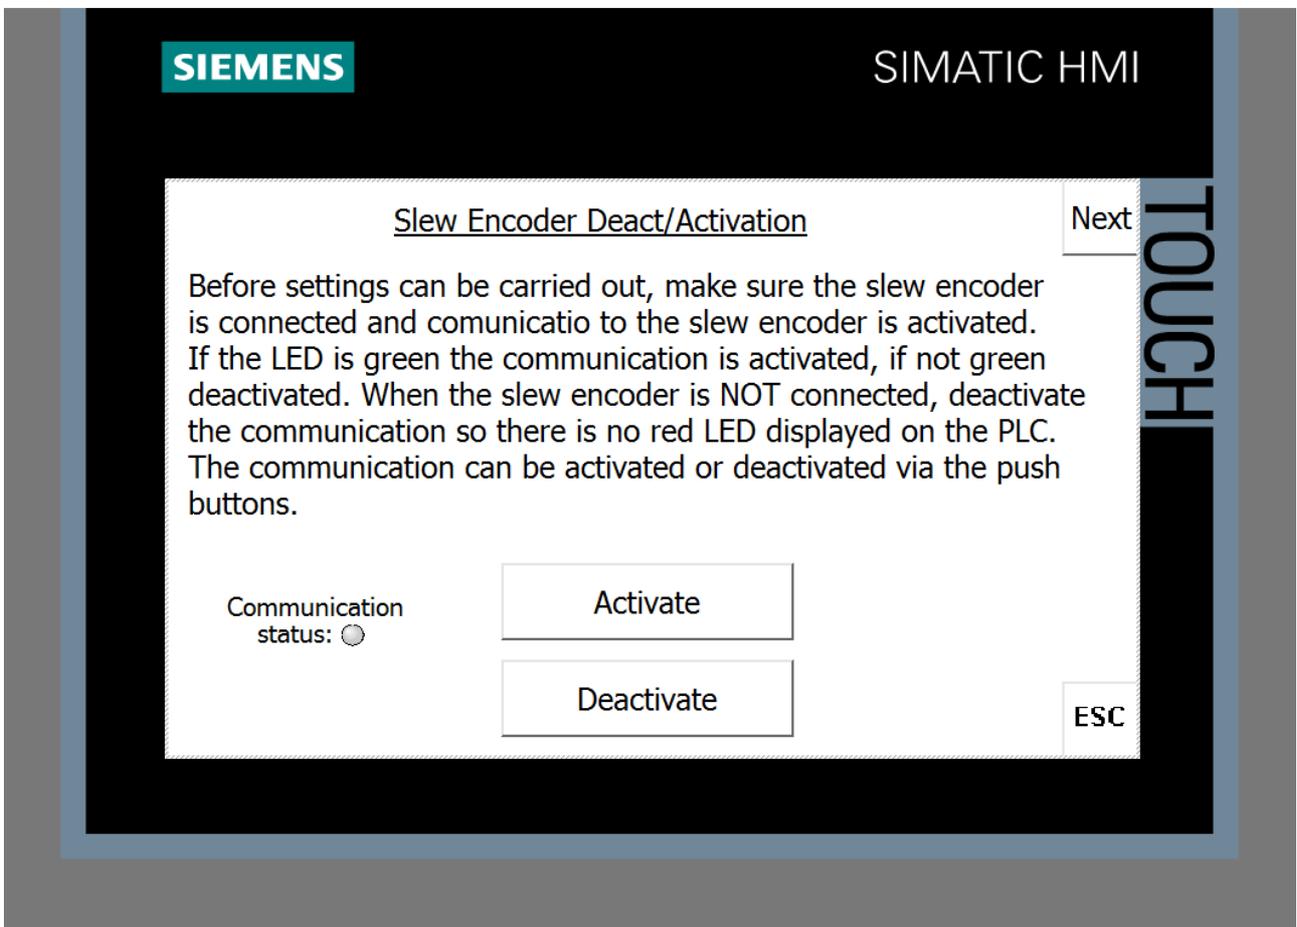
- When no slew encoder is connected to the PLC the slew encoder connection has to be deactivated via the slew encoder deact/activation screen on the settings screen.
- If the slew encoder is activated but not connected the PLC program will still work as it should, but a red LED indicator on the PLC will blink.

Slew encoder de-/activation screen

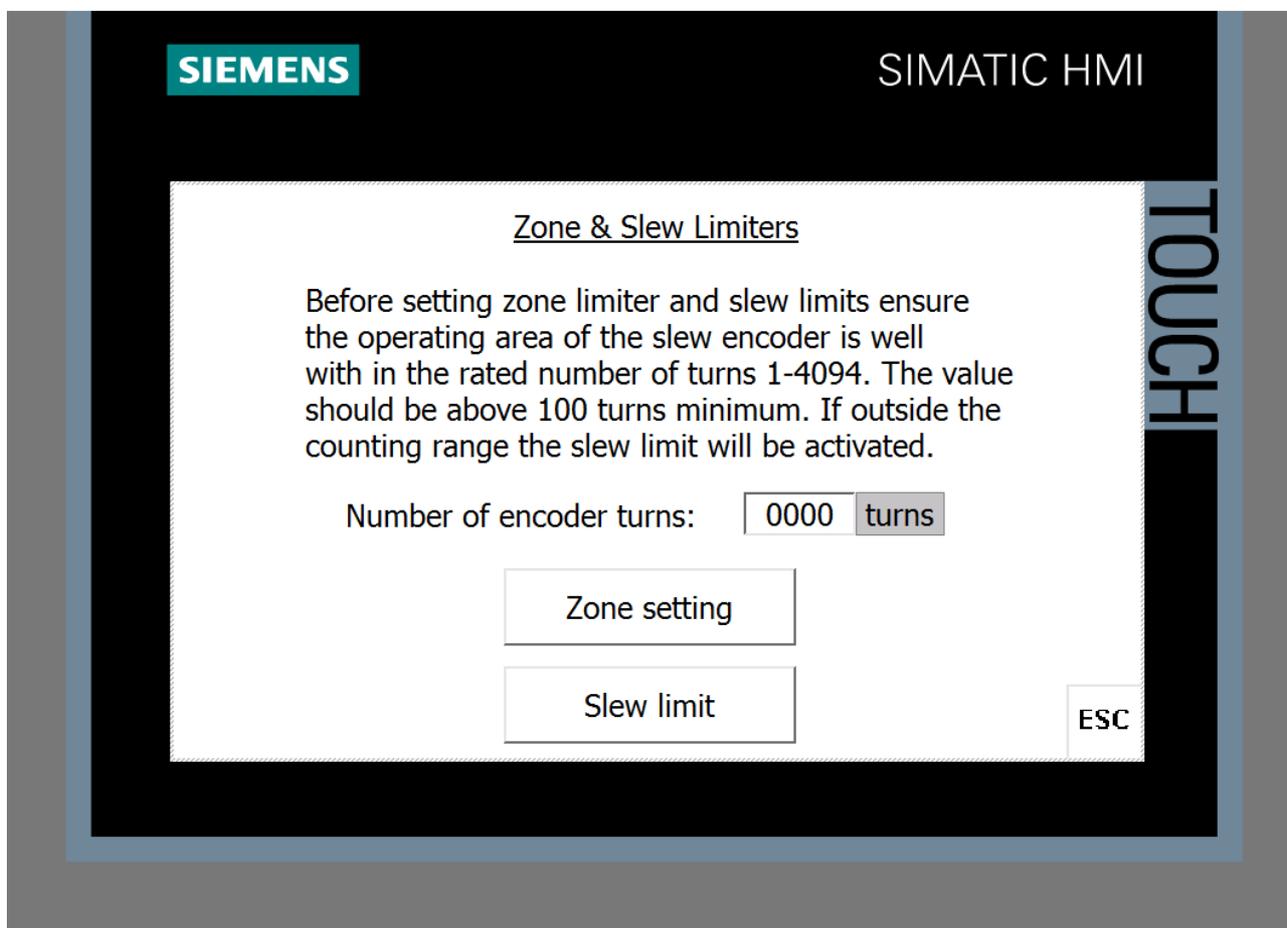
Encoder turns screen

- Before any slew limits are set, ensure the slew encoder is within the working range. The rated number of encoder turns must be within 1 to 4094. Before doing any settings the number of encoder turns should be minimum 100. If this is not the case mechanically turn the slew encoder shaft until the number of encoder turns are above 100.
- To set slew limits press the "Slew limit" button

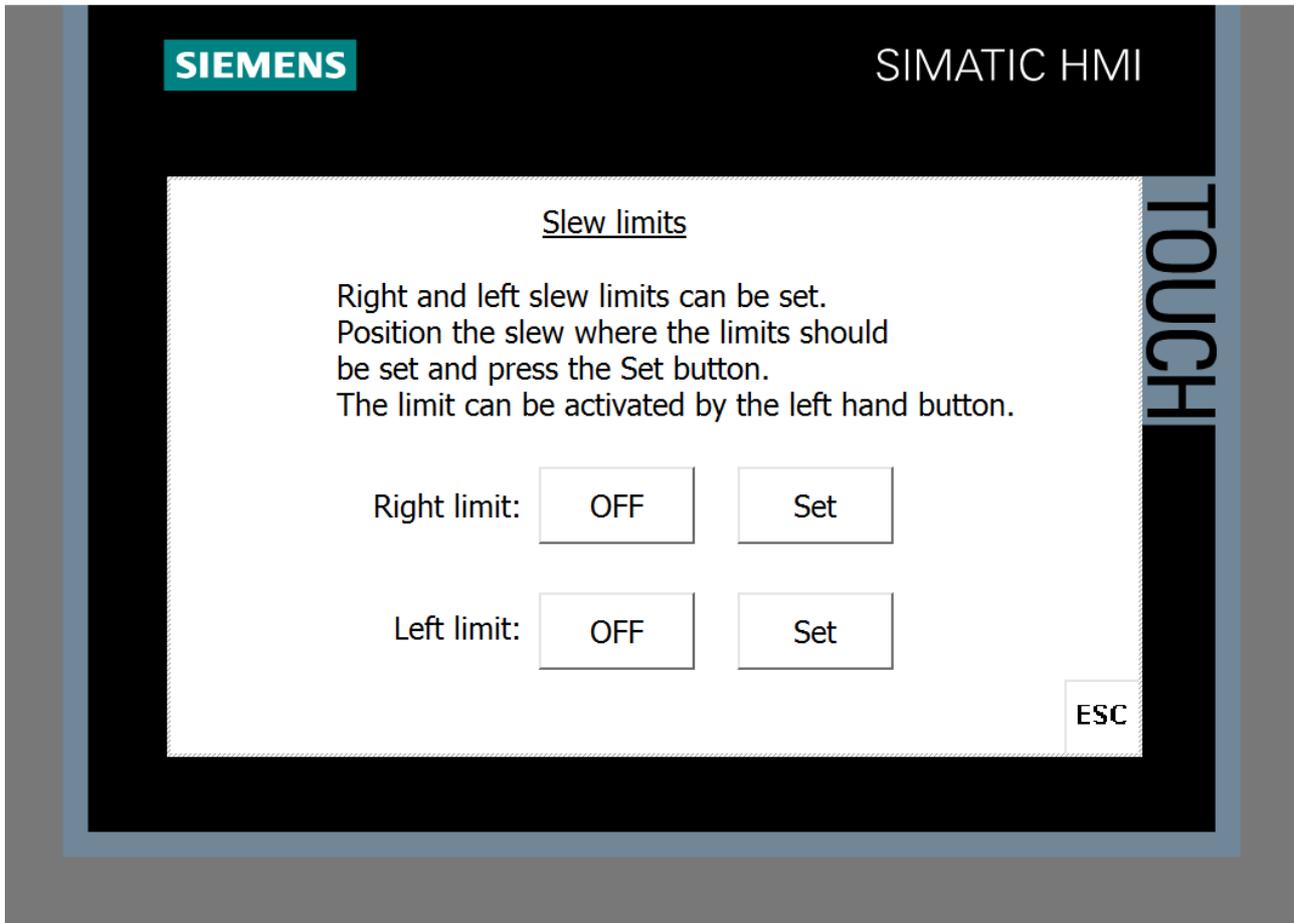
Slew limit settings

The slew limits are mostly used for main cable protection. A slew left limit and a slew right limit can be set.

- Slew the crane to the right position where the slew motion shall stop.
- Press the right limit "Set" button to set the slew right limit
- Press the right limit "OFF" button to activate the limit. The button will change to "Active"
- Press the right limit "Active" button to deactivate the limit. The button will change to "OFF"

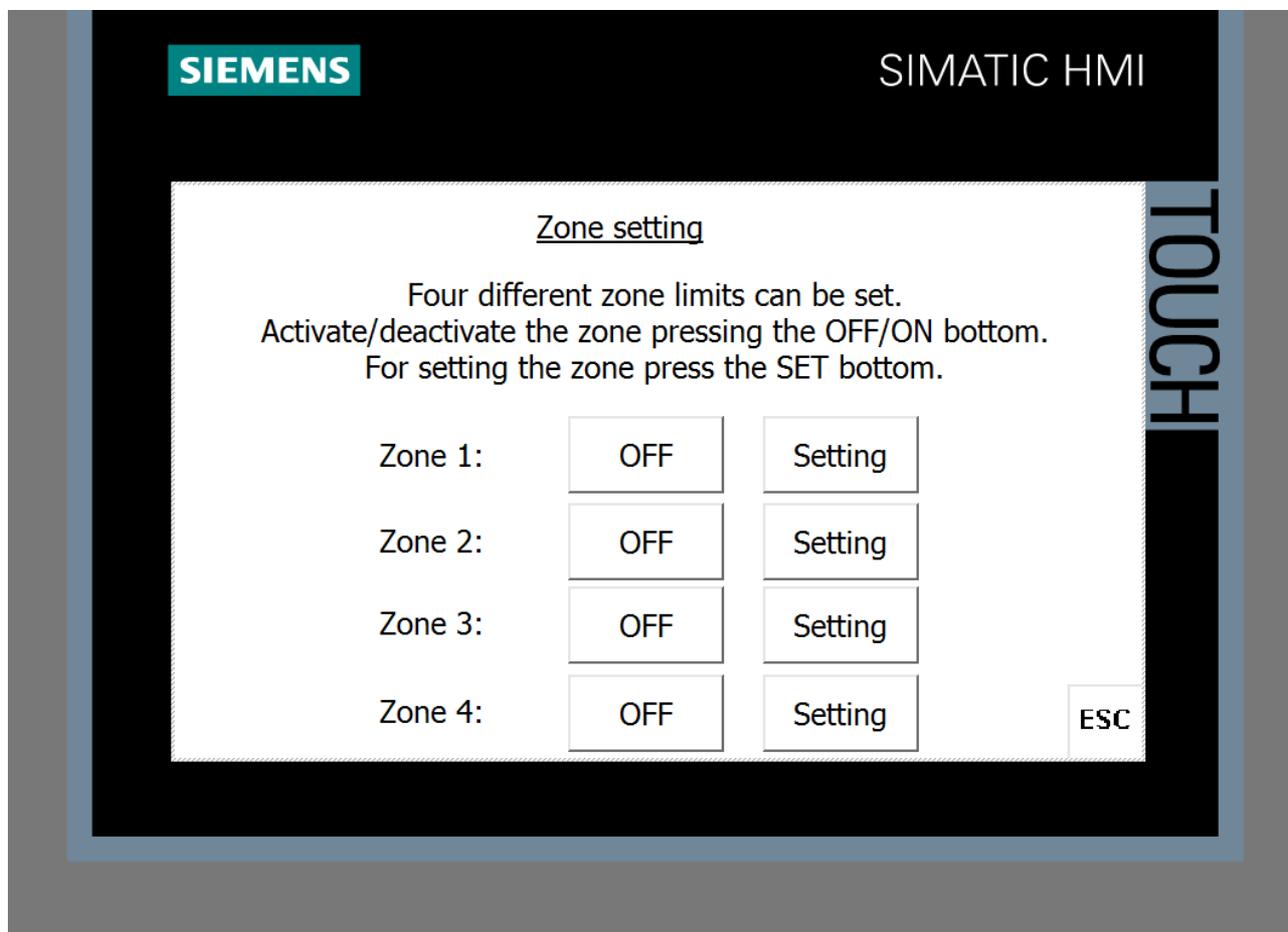
Zone setting screen

Four zone limits can be set.

Each of the four zone limits can be activated and deactivated by pressing the “OFF”/”Activated” button for each zone limits.
