# ELECTRICAL ADJUSTMENTS

<u>CONTENTS</u>	Page
Electrical connections.....	2
Start up the crane .....	2
Erection condition .....	3
Trolley radius and limit setting .....	6
Minimum trolley radius .....	7
Maximum trolley radius.....	8
Hoist limit settings.....	9
Hook height limit .....	10
Hoist depth limit.....	11
Wire part selection.....	12
Load/Moment settings.....	13
Load settings .....	14
Hoist zero load setting .....	15
Hoist maximum load setting .....	16
Moment .....	17
110% overload .....	17
Slew encoder deactivation/activation .....	18
Slew limits .....	19
Slew limit settings.....	20
Zone setting.....	21
Service .....	23
Alarm/event buffer.....	24
Hour counters .....	24
Joystick signals .....	25
Wind speed configuration .....	26
Set time & date.....	26
Display brightness.....	27
Flood light switch.....	27
Max. speed .....	28
Data Logging .....	29

## **Electrical connections**

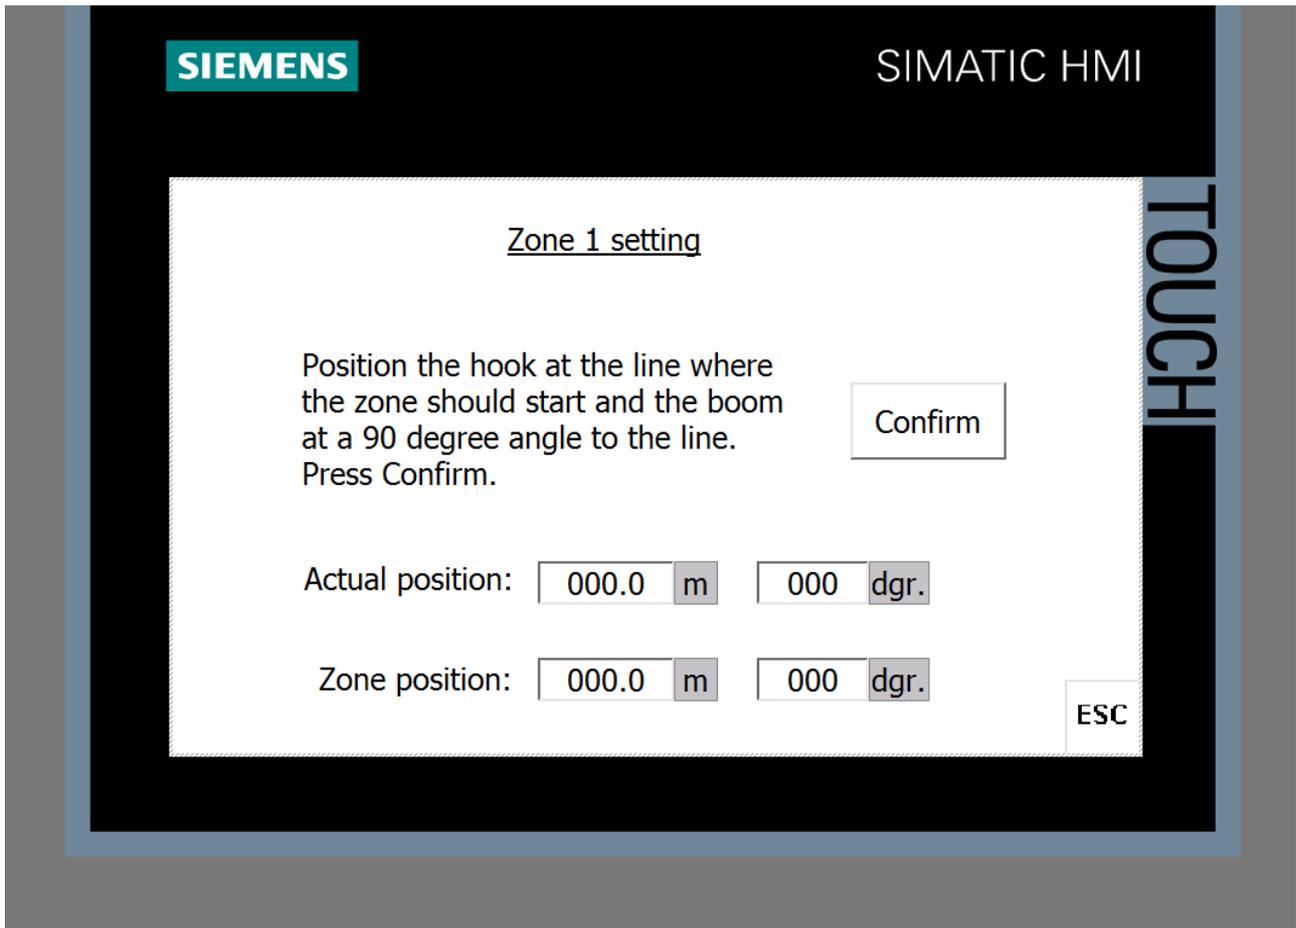
Zone 1 setting

- Place the hook at a 90 degree angle to the straight line where the zone limiter should stop the crane
- Press the “Confirm” button.

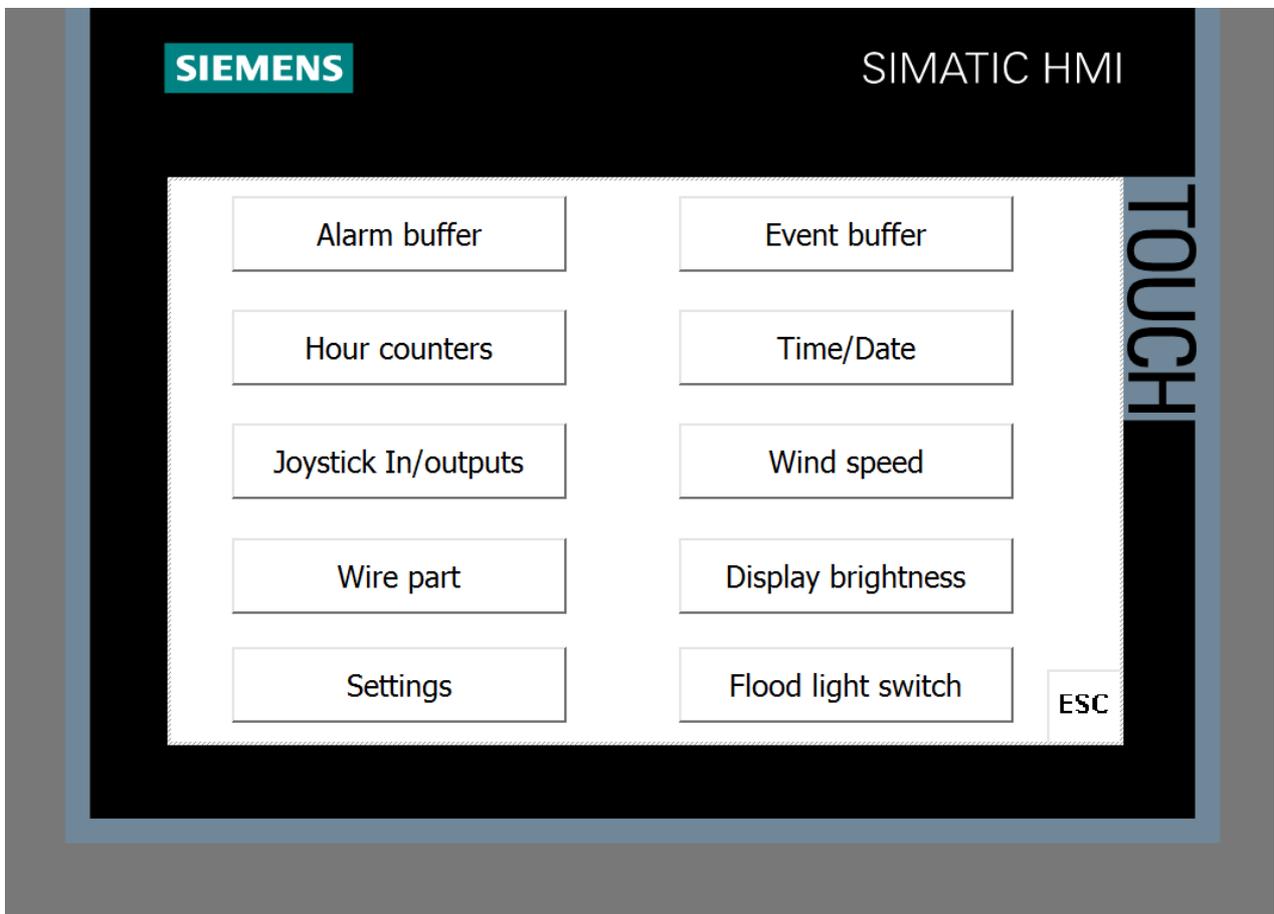
- alarm/event buffers
- hour counters
- joystick in/outputs & voltage
- wind speed configuration
- time & date
- screen brightness
- flood light D52 relay activation
- max. speed function

Setting screen

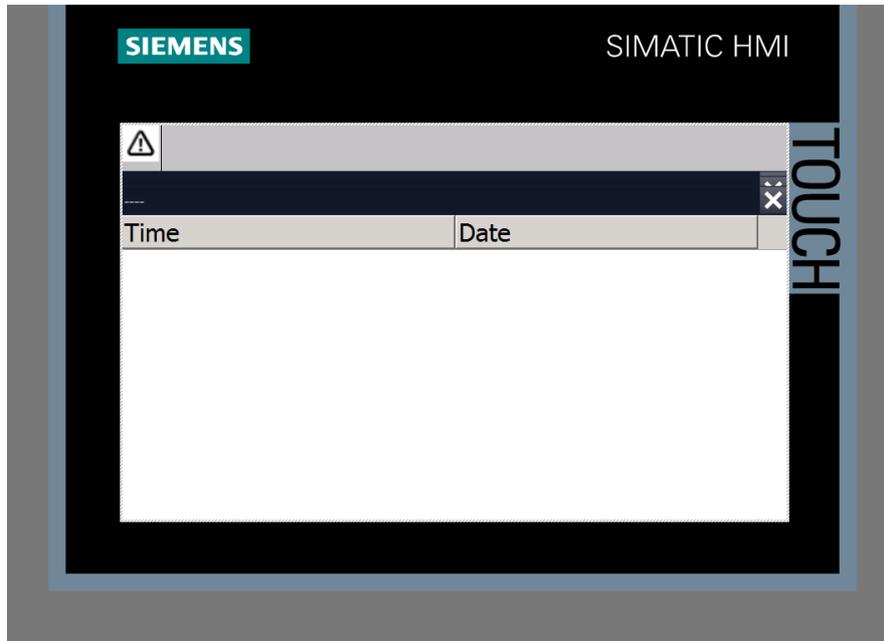
The last 99 alarms or events can be read in these screens. The buffers are circular logs and above 99 logs the last log will be deleted. The buffer is an internal memory bank and will be deleted, if the control system is left powerless for a longer period of time.

Alarm/event buffer

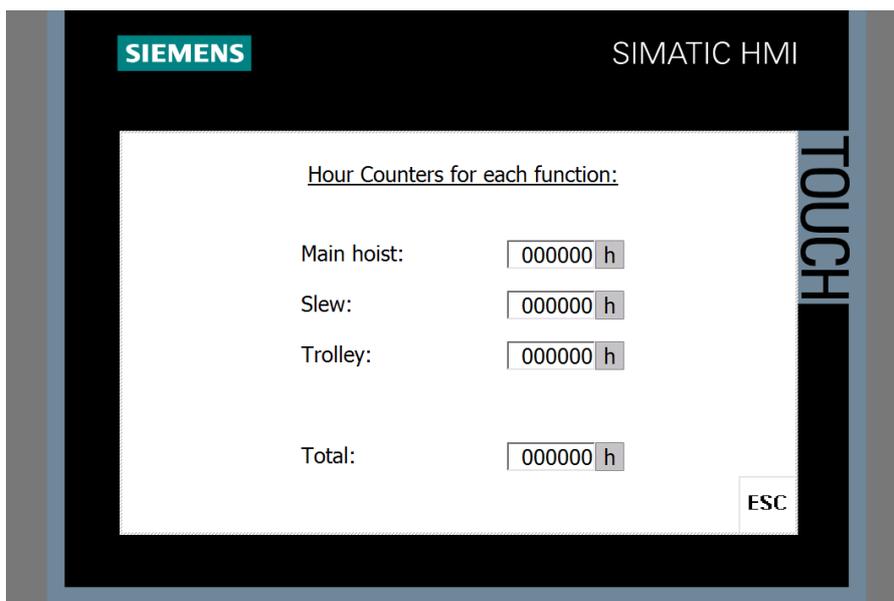
There is an active hour counter for each function. The “total” hour count is the active operation time for the infeed. Access to this screen is through the Select screen.

Hour counter screen

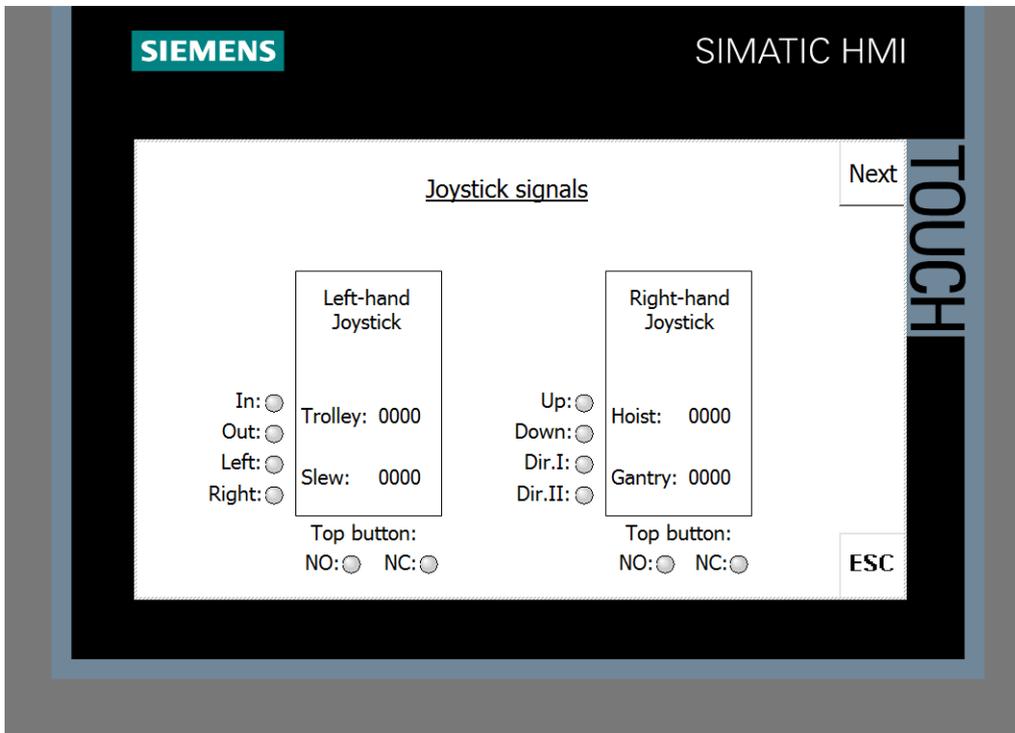
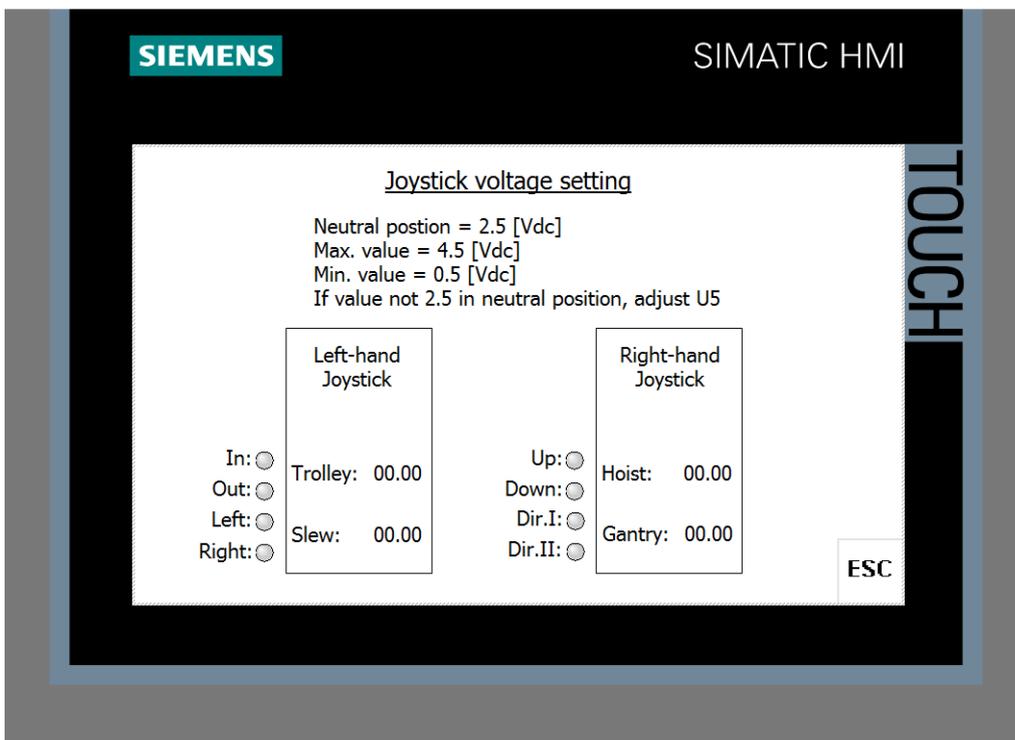
The joystick signals can be checked via the display under the. Access to this screen is through the Select screen.

Joystick inputs screen

Joystick voltages screen

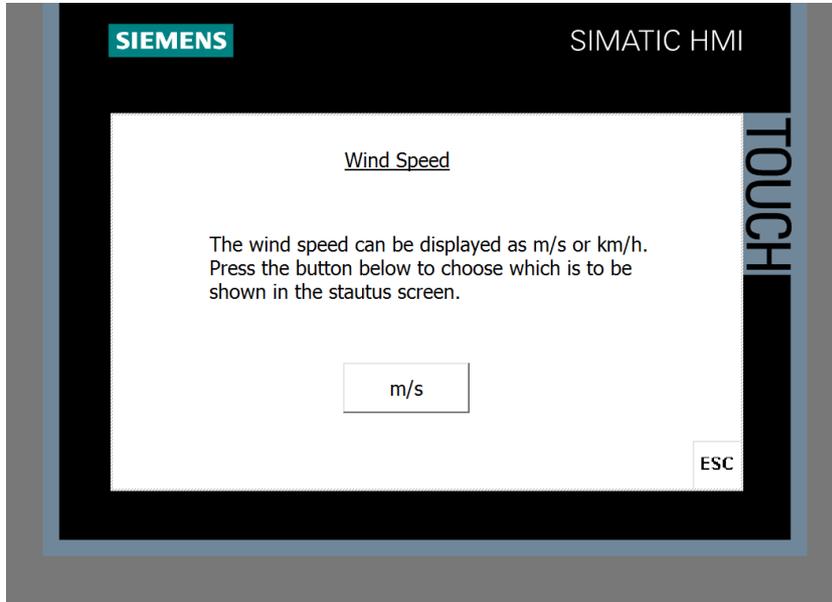
- The crane driver can choose to have the wind speed in m/s or km/h
- Press the "Wind speed" button in the select screen
- Press the button

Wind speed screen

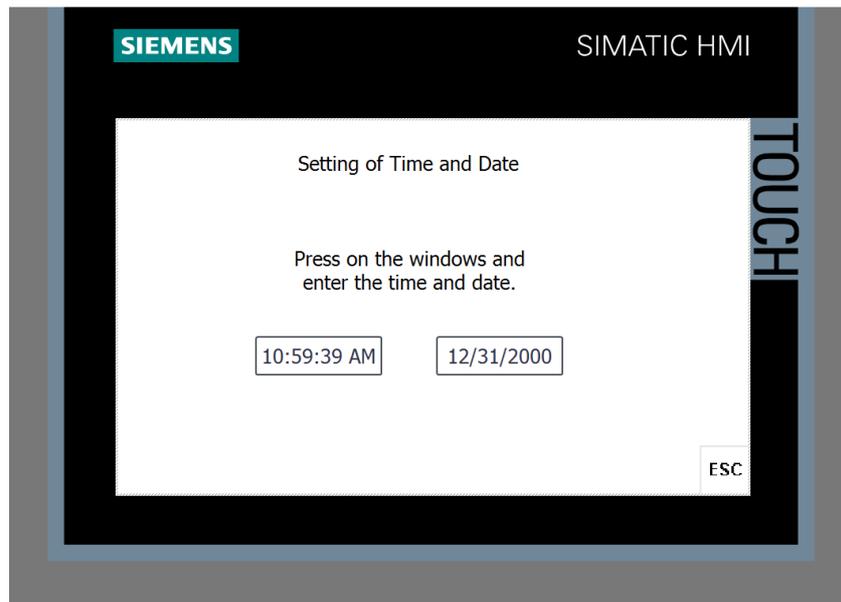
- Press the time/date window on the screen
- A keyboard appears, enter time/date with the corresponding characters as shown
-

Time & date screen

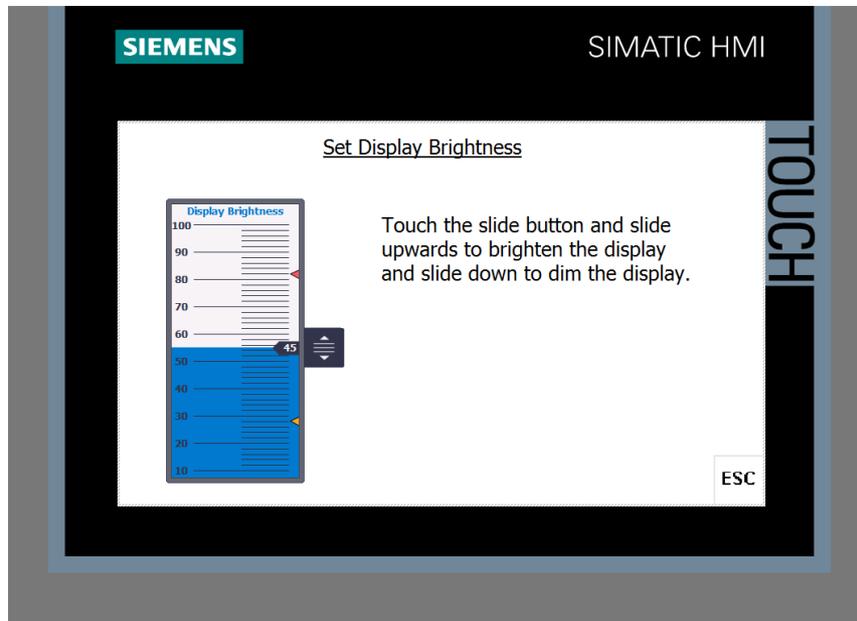
Press the display brightness button on the select screen. Touch and slide the slide button up to increase brightness and down to decrease brightness.

Display brightness screen

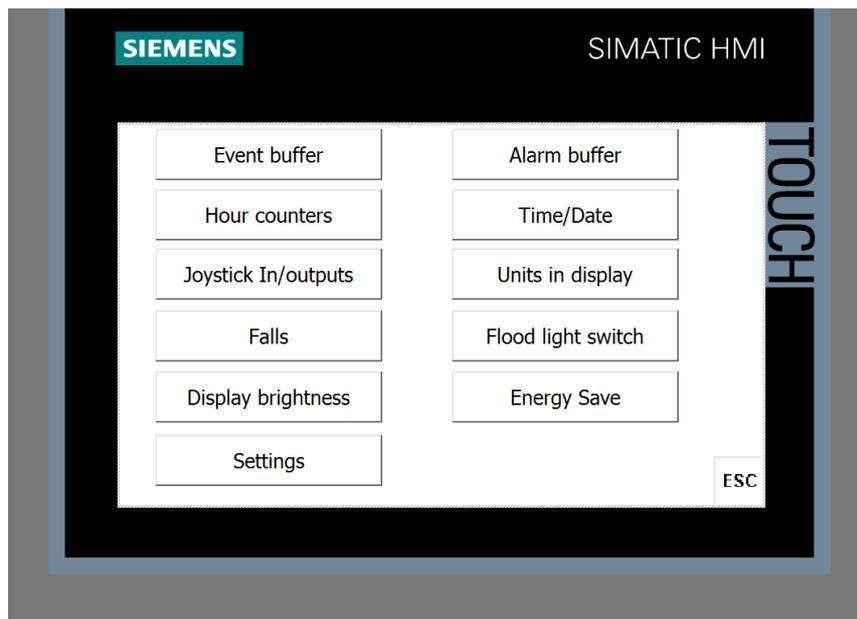
- Press the “Flood light switch” button on the select screen
- Everytime the button is pressed, relay D52 will toggle between ON and OFF

Select screen

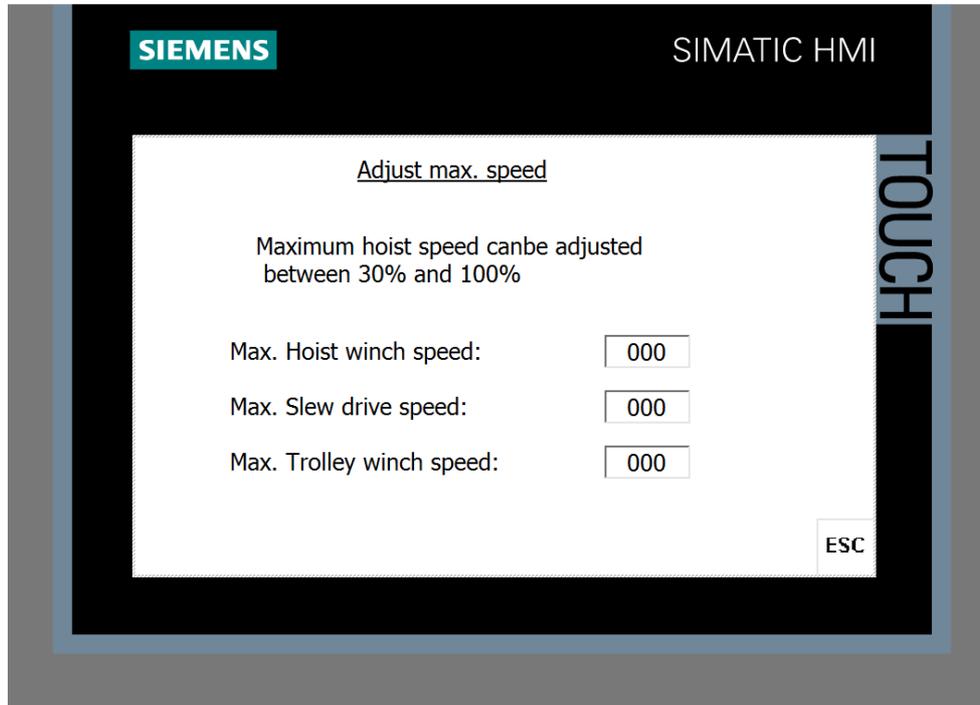
Max. speed screen

Here the maximum speed of the hoist, slew or trolley can individually be reduced to a minimum of 30% of the rated speed. A value between 30% and 100% can be chosen, factory setting is 100%

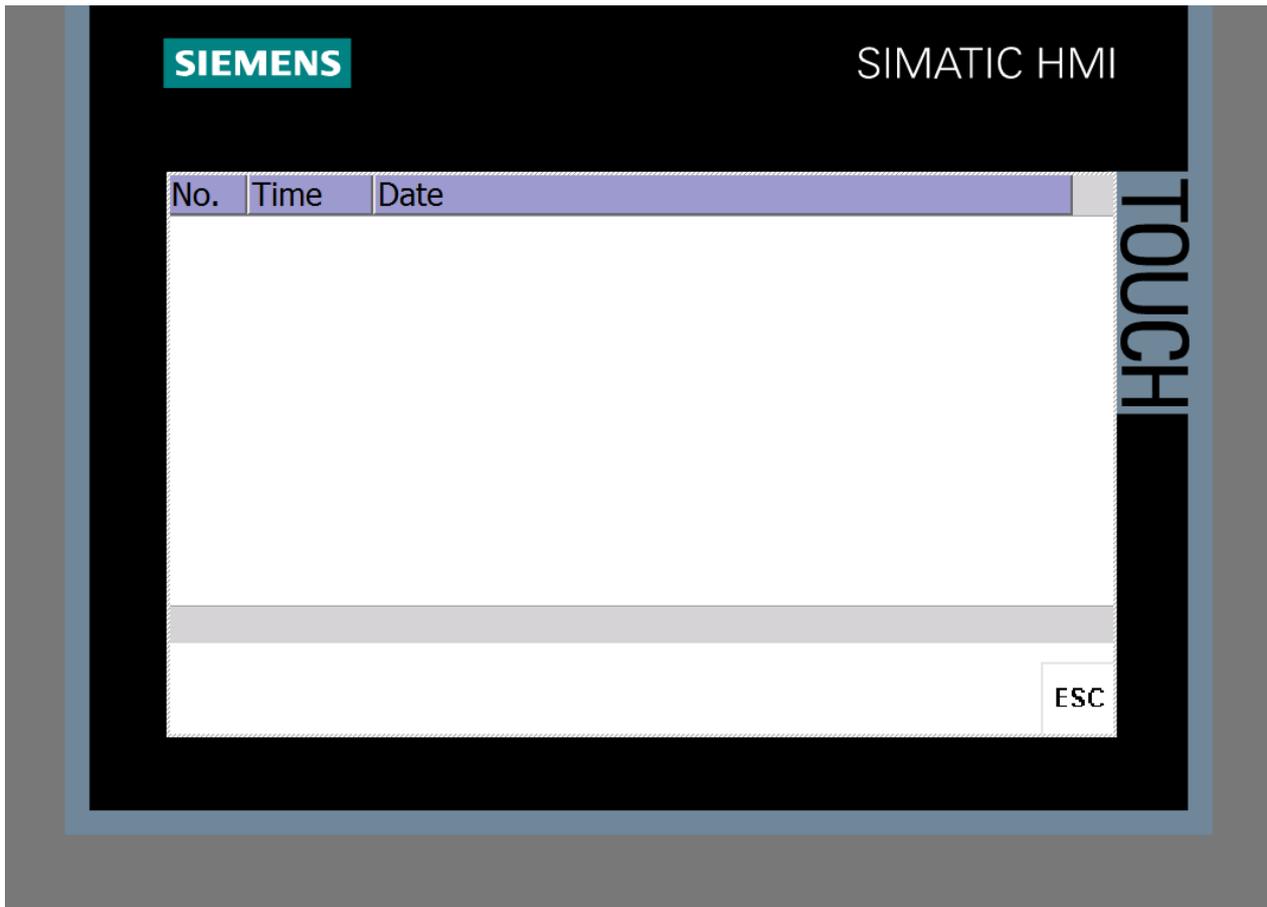
- **Destription:** All logs are recorded with a date and time stamp.
  - In the settings screen press the “Data Log” button
  - On the data log screen the logged data will be stored and read directly from the MMC flash memory card on the back of the panel.

Data log screen

**Data downloading:** All logs are recorded onto the MMC flash memory card fitted into the display. The logs are saved as a Comma Separated Value (.csv) file which can be viewed via Excel. The log is a cyclic logging system and 50000 logs will be registered. The MMC flash memory card can be removed from the display and with a standard flash card reader the file can be copied to a lap top or a stationery office computer.

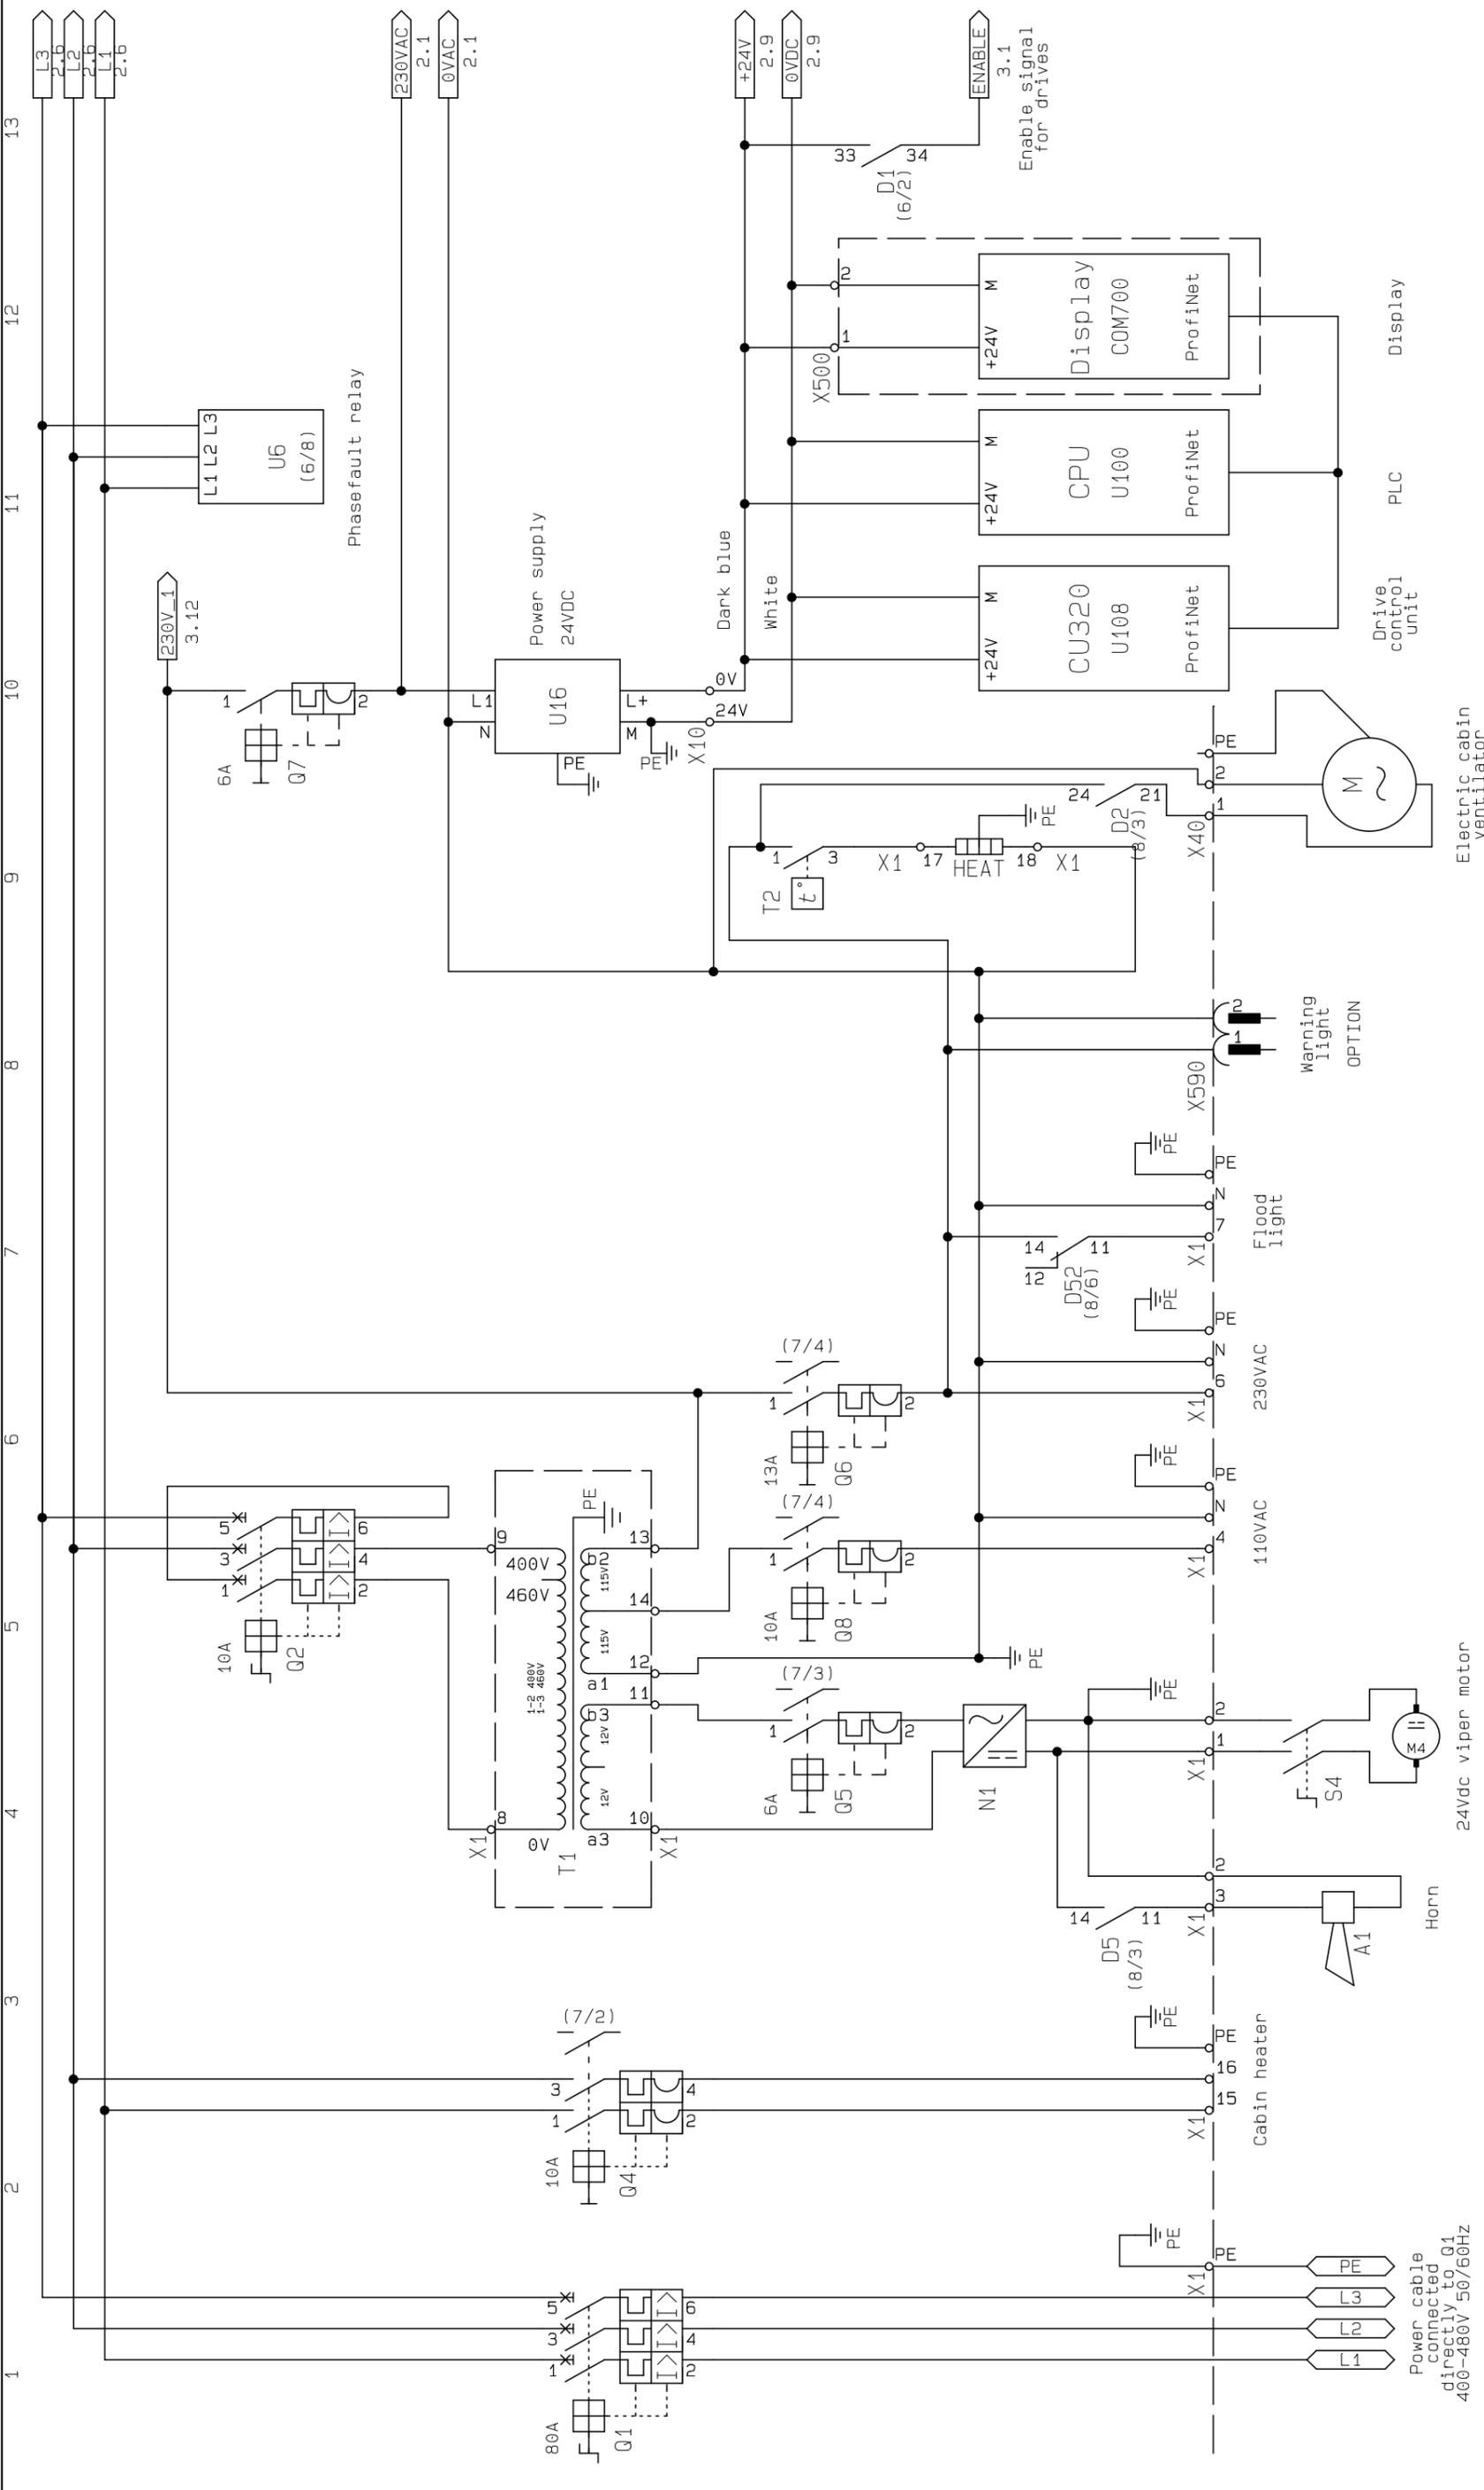
Project title: K250 S/NI292		Drawn: JBN	Drawing no.: 48.00059516
Pagetitle: Power and control supply		Last prt.: 02-03-2018	Rev.: 00
Kröll Cranes A/S Nordkranvej 2, 3540 Lyngø Tlf. +45 48 18 74 00 Fax. +45 48 18 88 07 www.krollcranes.com		Last changed: 08-02-2018	Order no.: 11:14
Power cable connected directly to G1 400-480V 50/60Hz		Page 1	of 13

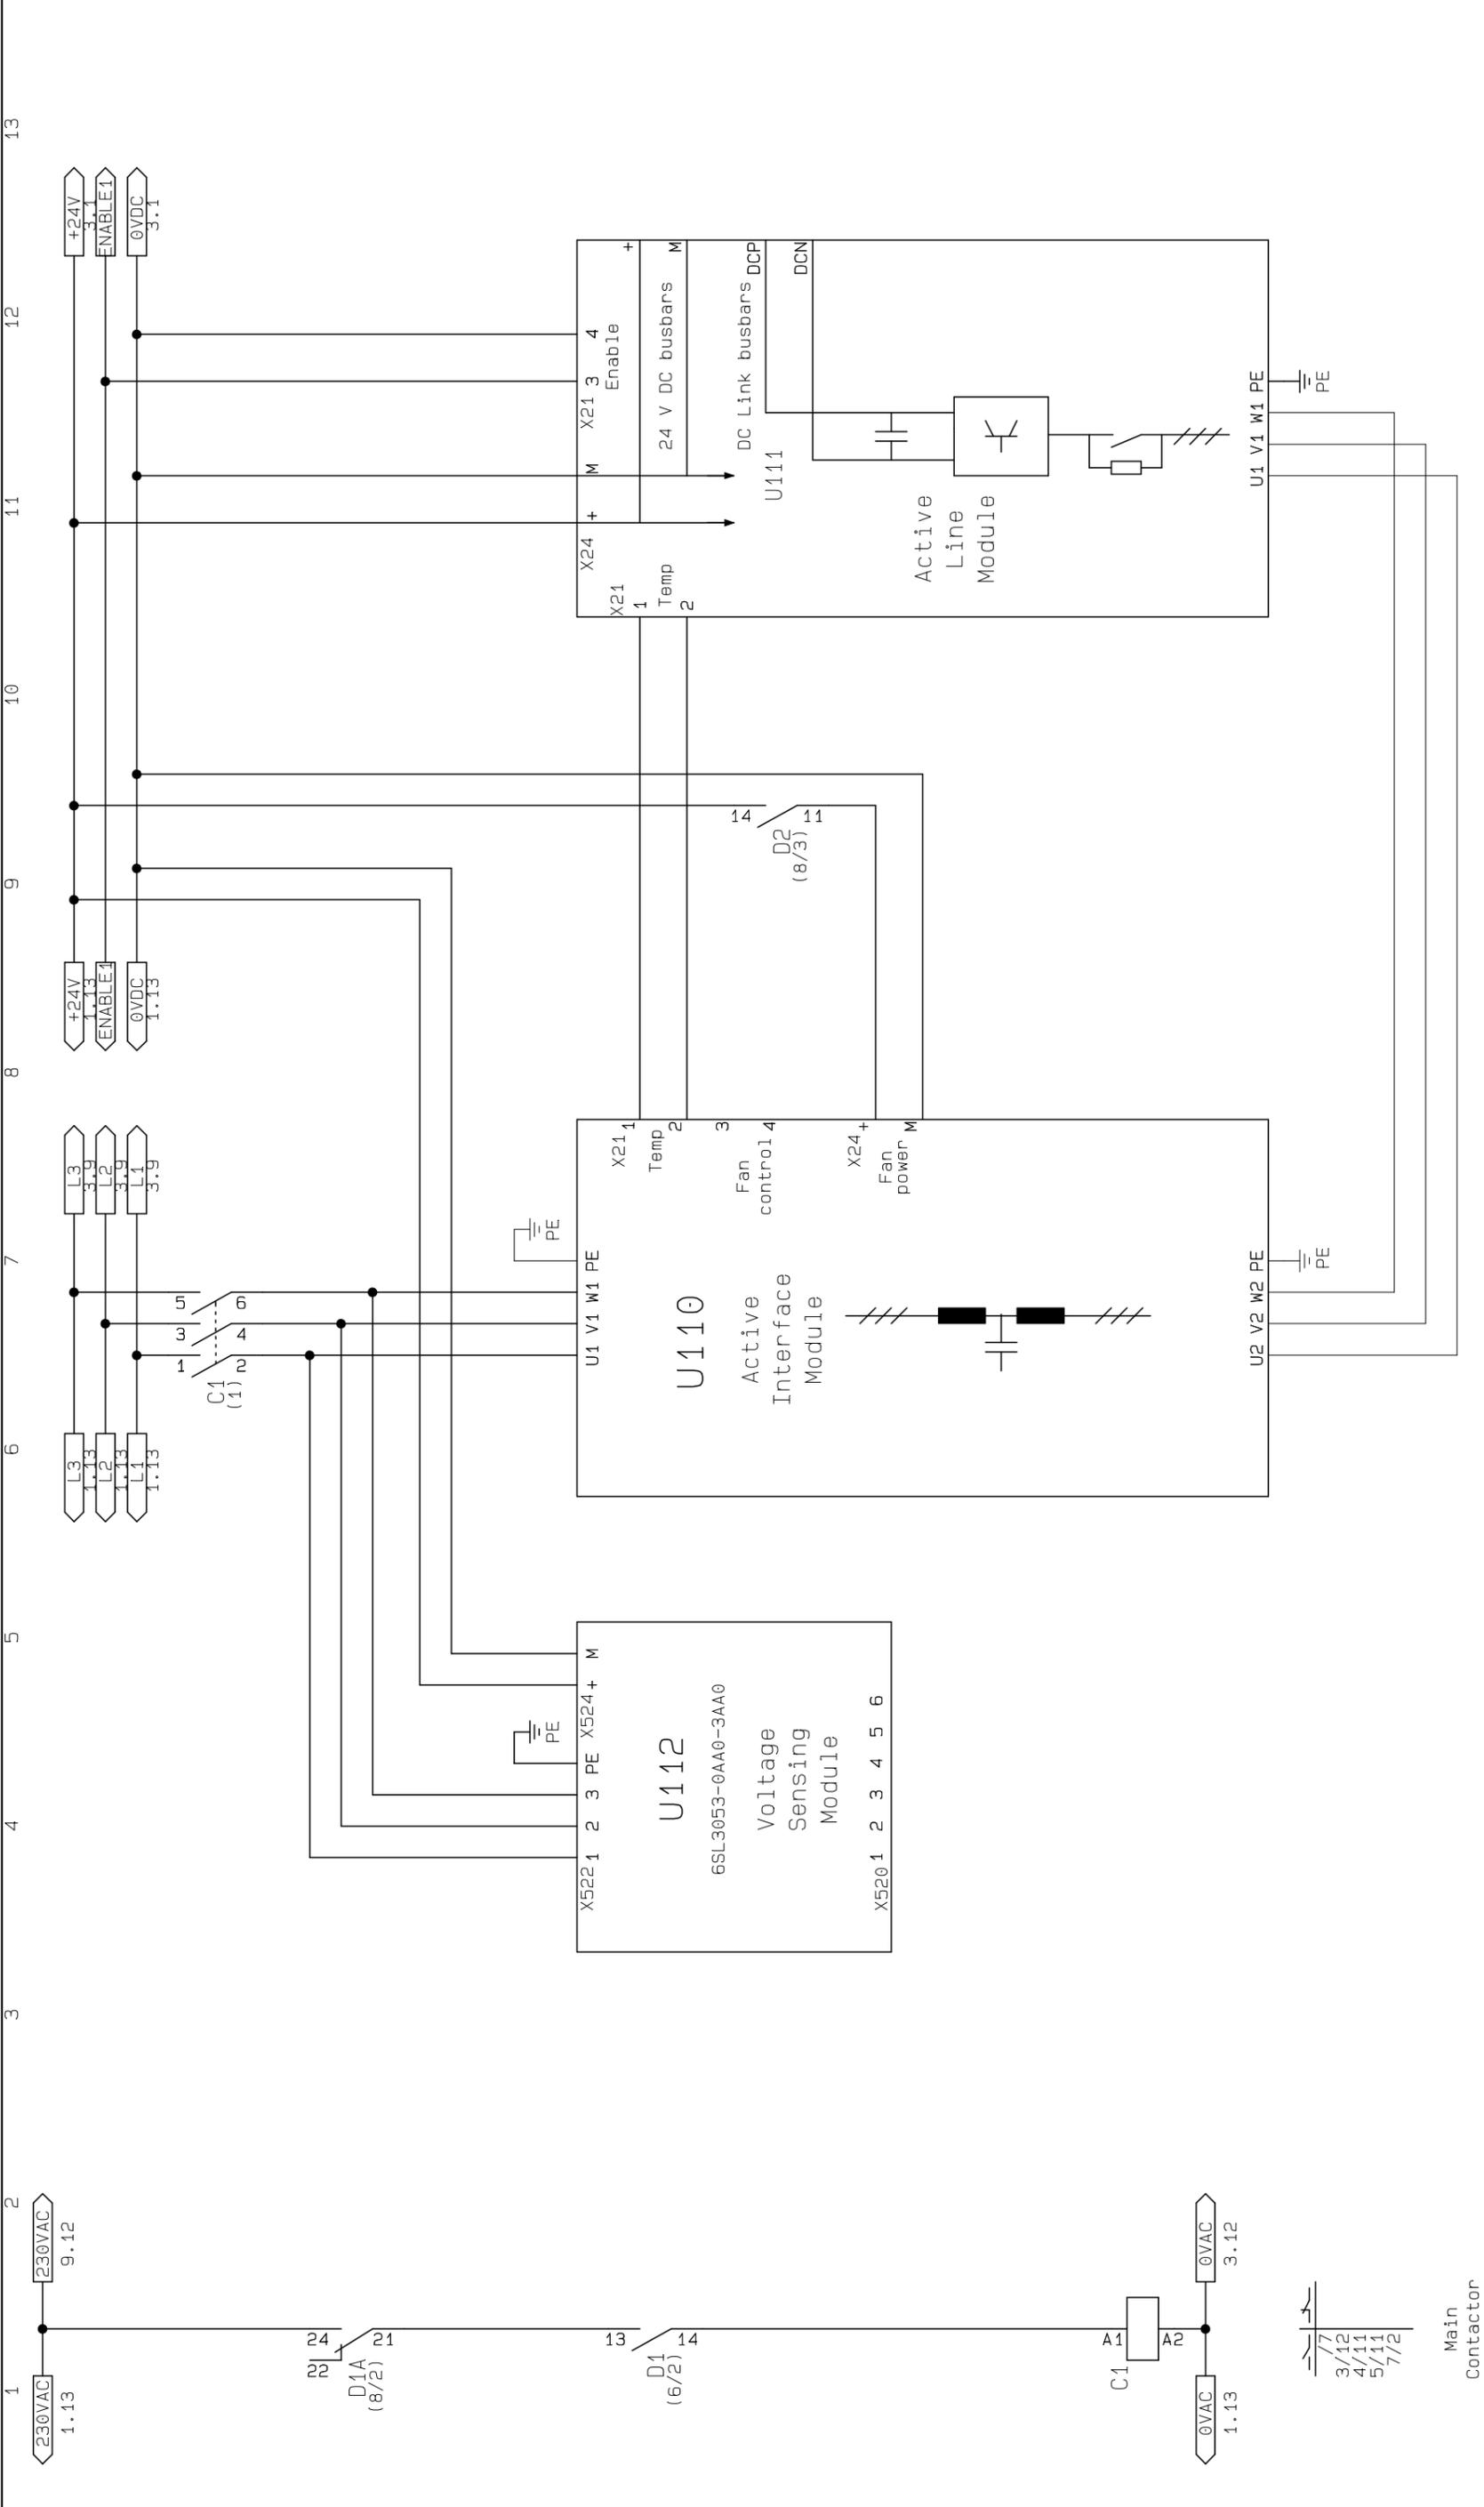
<p><b>Kroll Cranes A/S</b>          Nordkranvej 2, 3540 Lyngø          Tlf: +45 48 18 74 00          Fax: +45 48 18 88 07          www.krollcranes.com</p>	Project title: K250 S/NI292 Pagetitle: Infeed	Drawn: JBN	Drawing no.: 48.00059516 Rev.: 00
	Last prt.: 02-03-2018 Last changed: 19-06-2017	Order no.: 11:14	Page 2 of 13

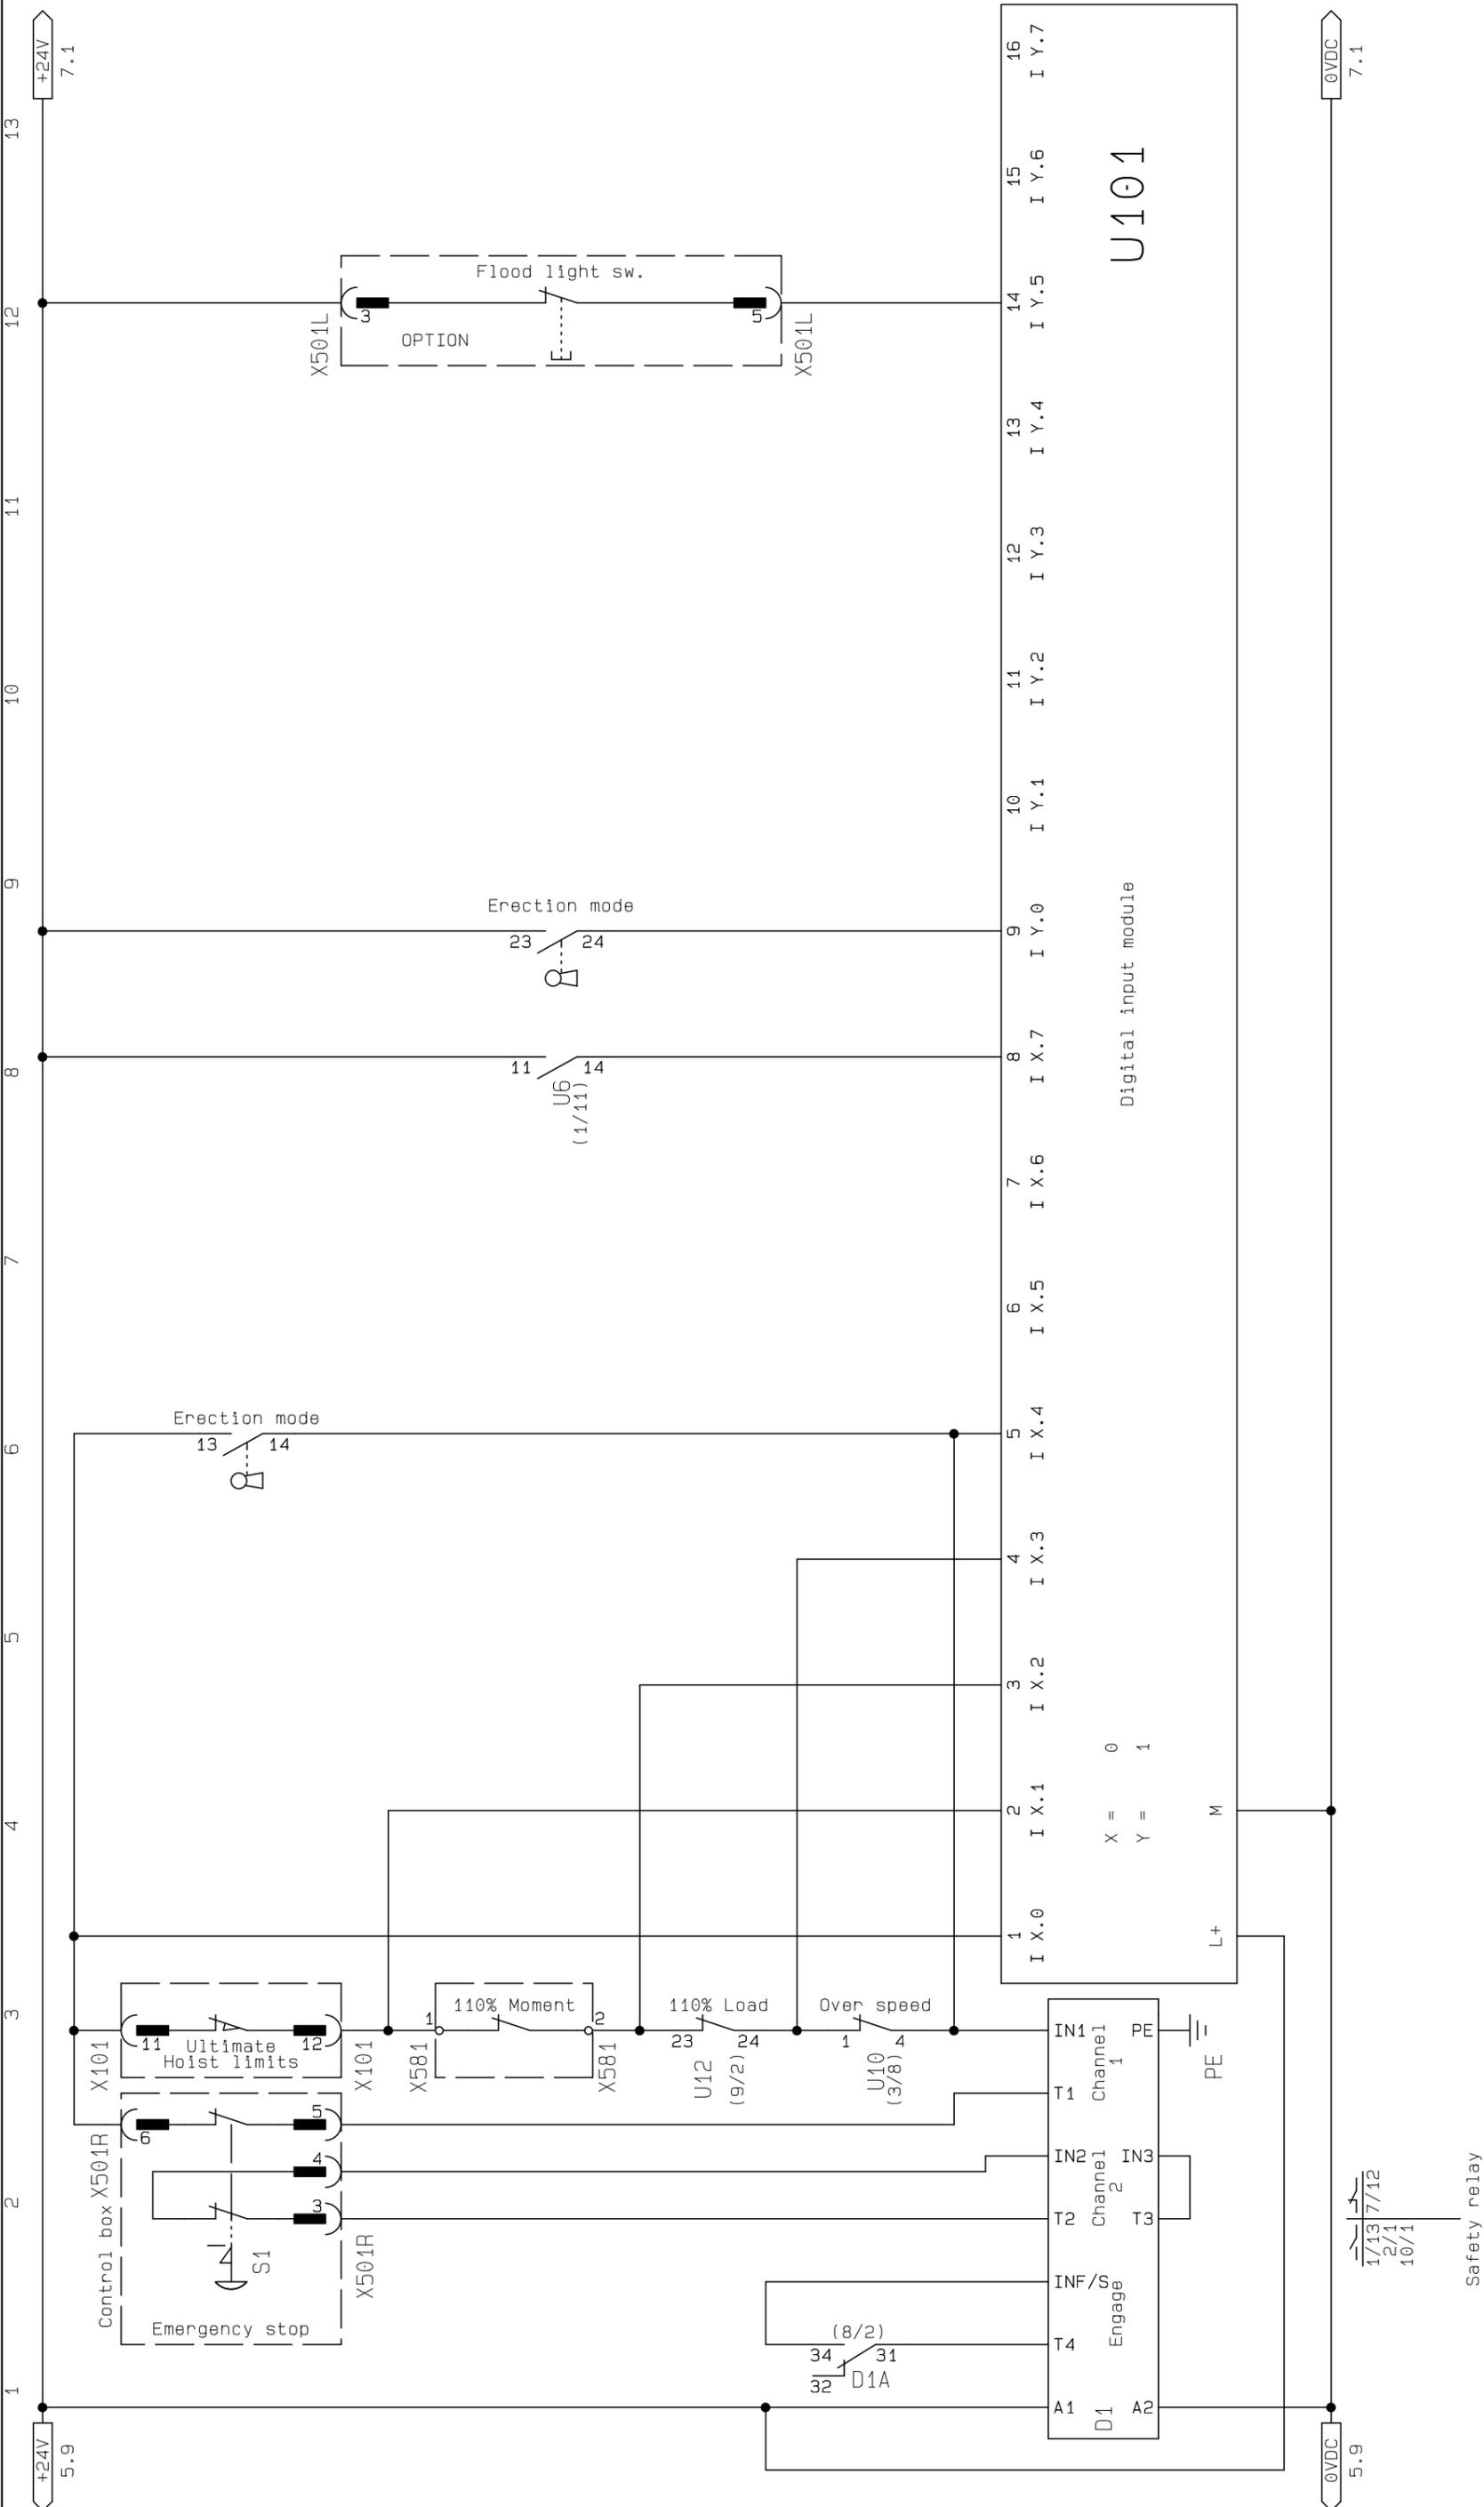
Project title: K250 S/NI292	Drawn: JBN	Drawing no.: 48.00059516
Page title: Safety relay and digital inputs	Last prt.: 02-03-2018	Rev.: 00
