# ELECTRICAL ADJUSTMENTS

<u>CONTENTS</u>	Page
Electrical connections.....	2
Start up the crane .....	2
Erection condition .....	3
Trolley radius and limit setting .....	6
Minimum trolley radius .....	7
Maximum trolley radius.....	8
Hoist limit settings.....	9
Hook height limit .....	10
Hoist depth limit.....	11
Wire part selection.....	12
Load/Moment settings.....	13
Load settings .....	14
Hoist zero load setting .....	15
Hoist maximum load setting .....	16
Moment .....	17
110% overload .....	17
Slew encoder deactivation/activation .....	18
Slew limits .....	19
Slew limit settings.....	20
Zone setting.....	21
Service .....	23
Alarm/event buffer.....	24
Hour counters .....	24
Joystick signals .....	25
Wind speed configuration .....	26
Set time & date.....	26
Display brightness.....	27
Flood light switch.....	27
Max. speed .....	28
Data Logging .....	29

## **Electrical connections**

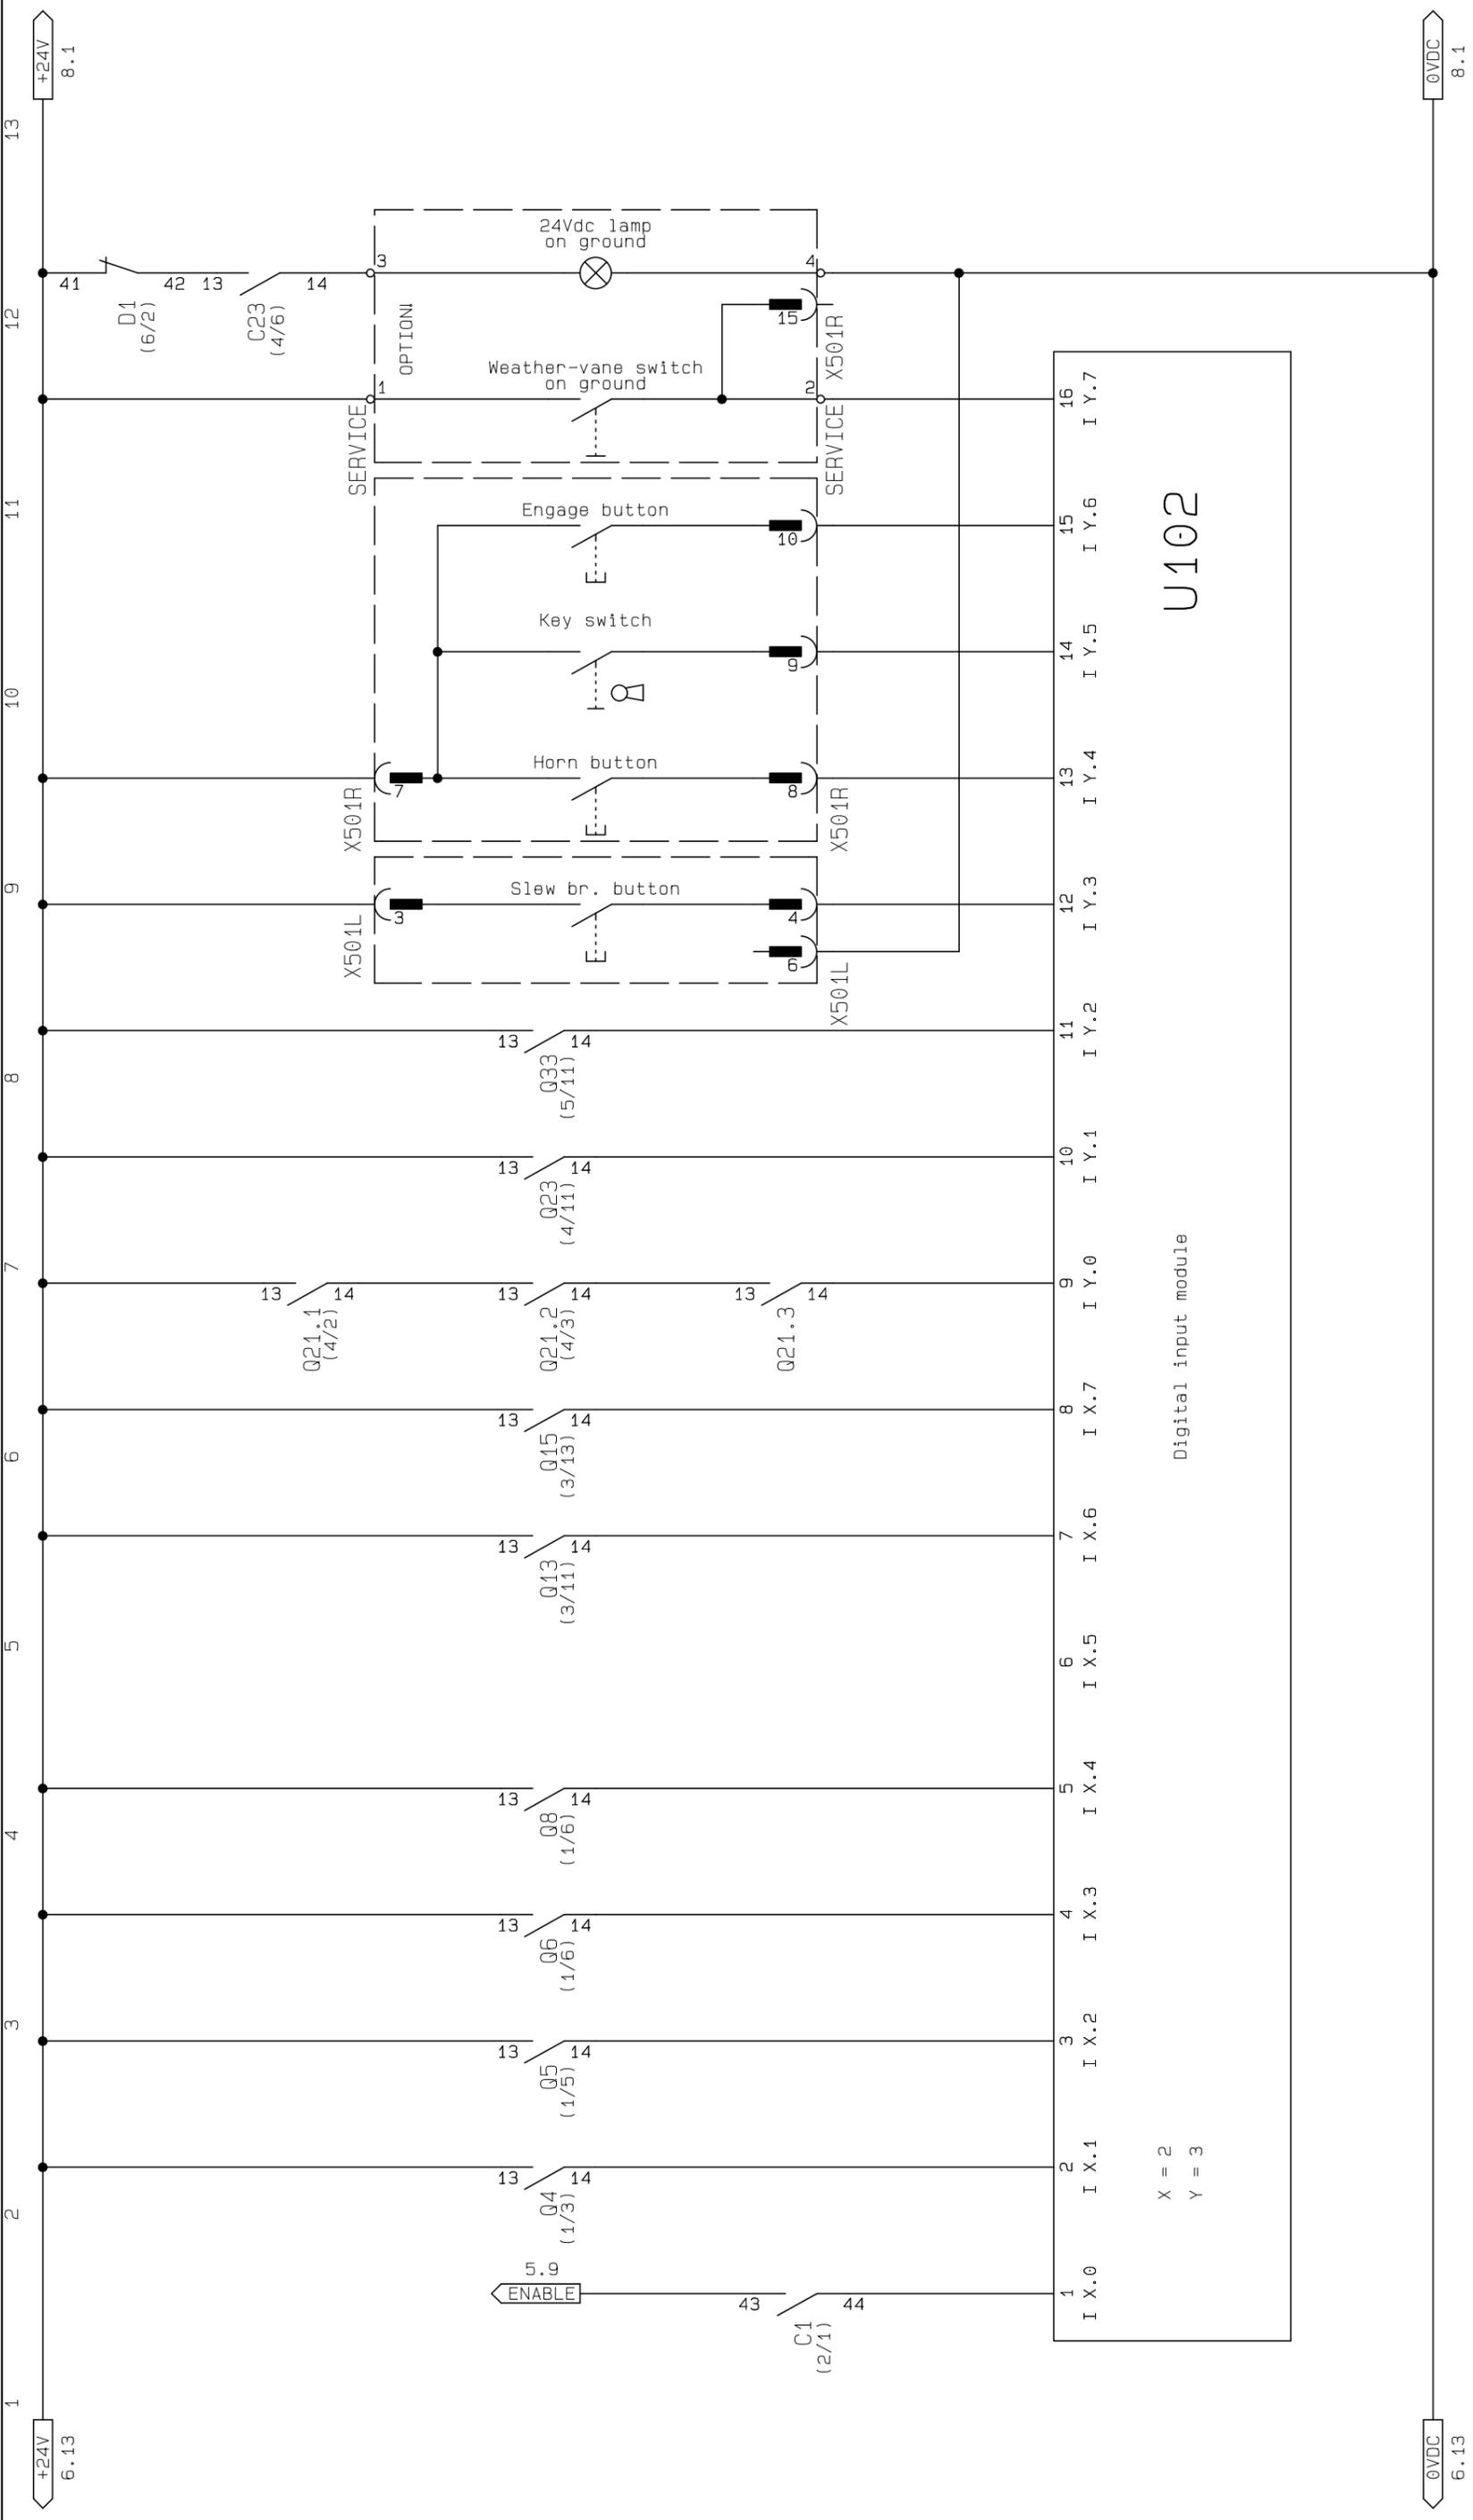
U102

Digital input module

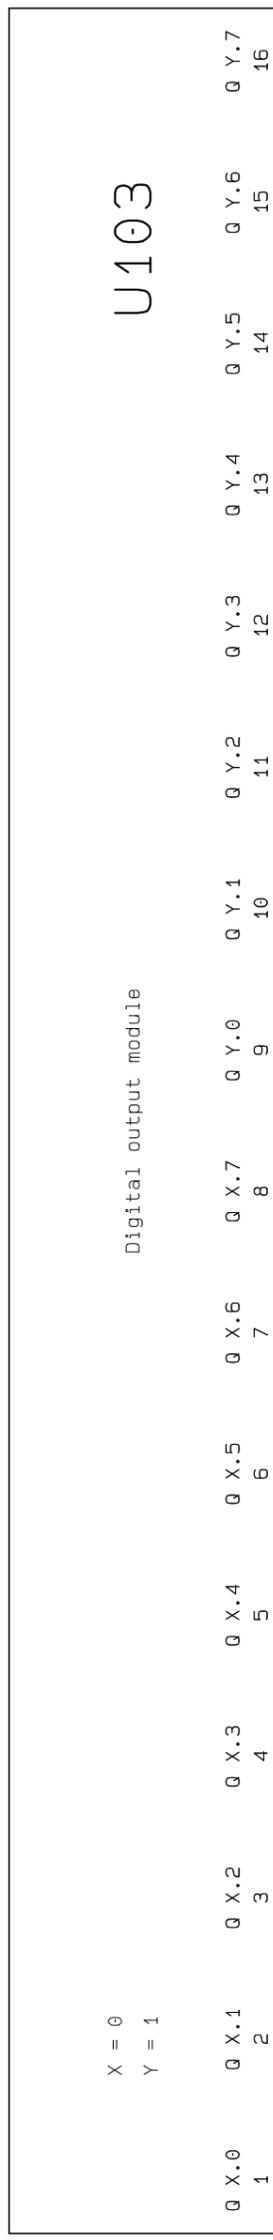
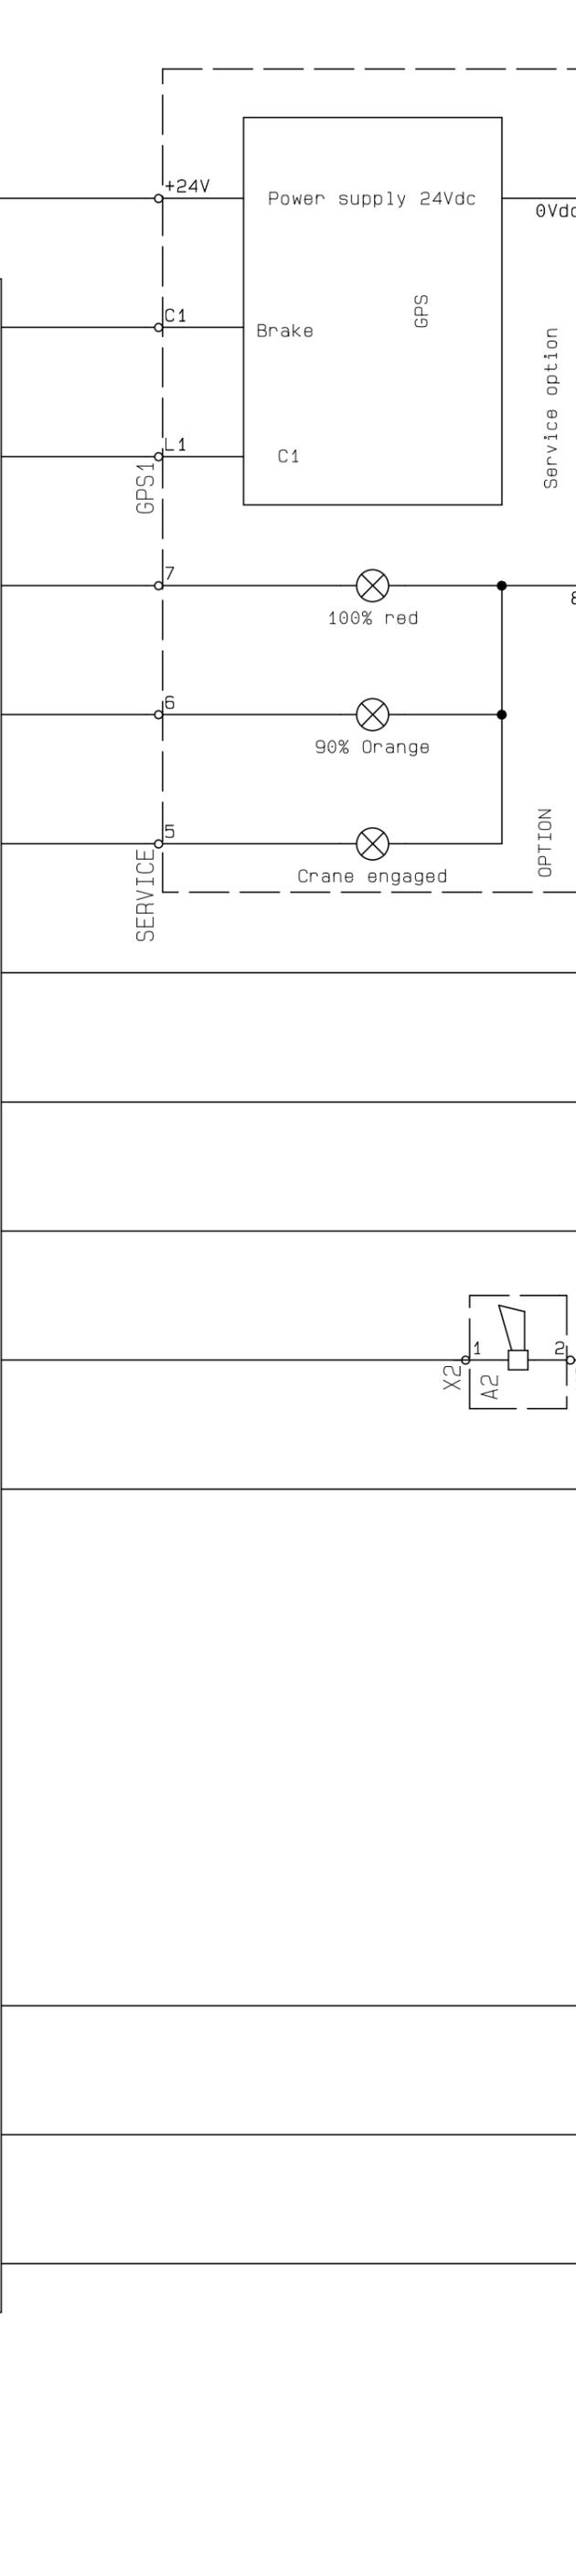
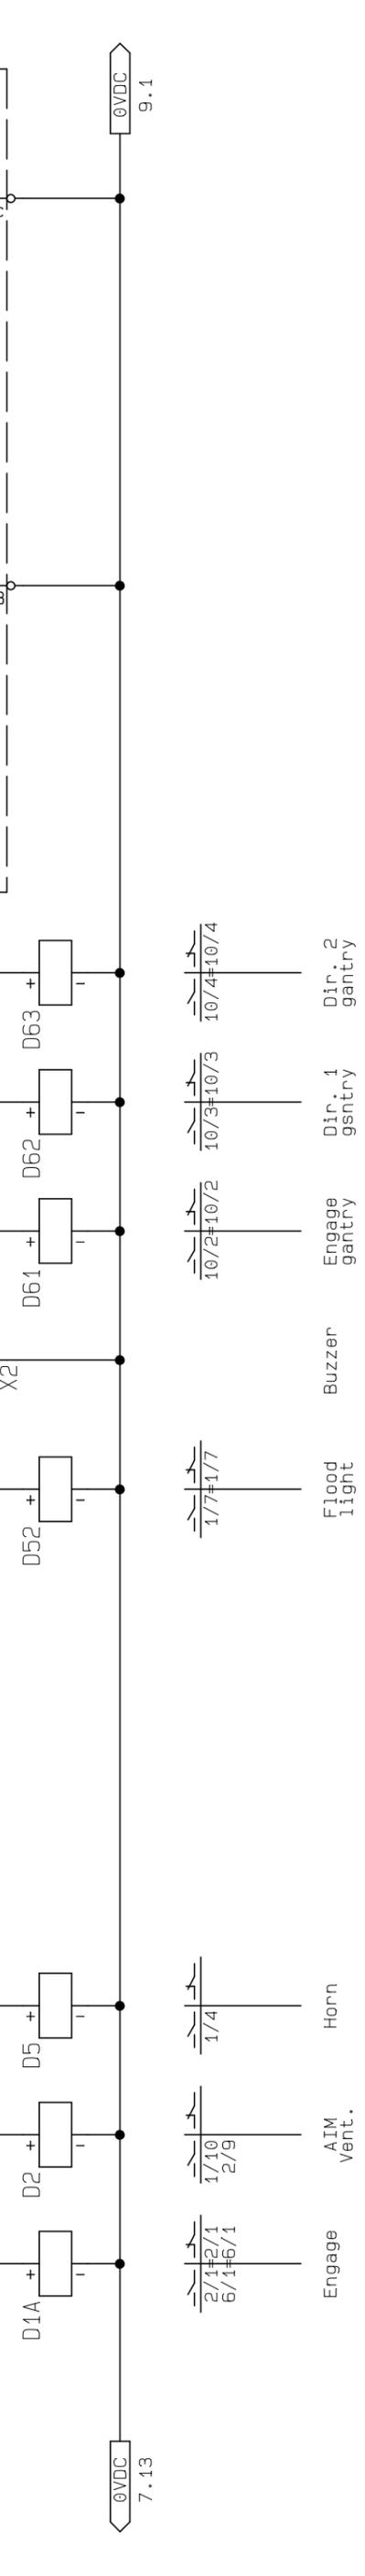
<b>Kroll Cranes A/S</b> Nordkranvej 2, 3540 Lyngø Tlf: +45 48 18 74 00 Fax: +45 48 18 88 07 www.krollcranes.com	Project title: K250 S/N1292	Drawn: JBN	Drawing no.: 48.00059516
	Page title: Digital inputs		Rev.: 00
		Last prt.: 02-03-2018	Order no.:
		Last changed: 20-06-2017	Page 7 of 13
