No.	Designation	Identification	No. of pages
1	Alarm list	5735-00	1
2	Electrical Adjustments	5736-00	30
3	Power and control supply	48.00059430-00	13
4	Parts list	48.00059430-00	3
5	Wiring top crane	48.00059431-00	1
6	Parts list	48.00059431-00	1
7	Parts list – Drivers cabin	48.00059432	1
8	Faults and alarms	Sinamics	259

# **ELECTRICAL ADJUSTMENTS**

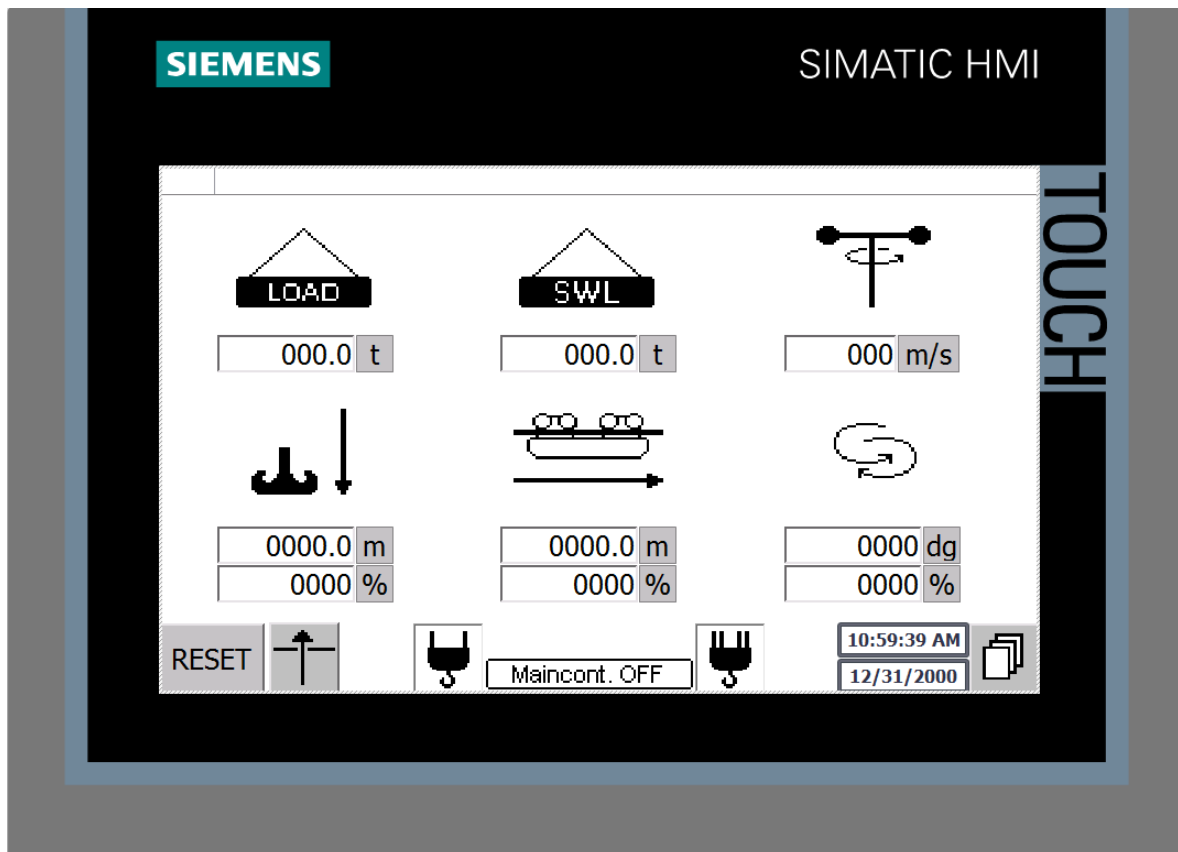
Status screen

- Press the change page button on the screen display

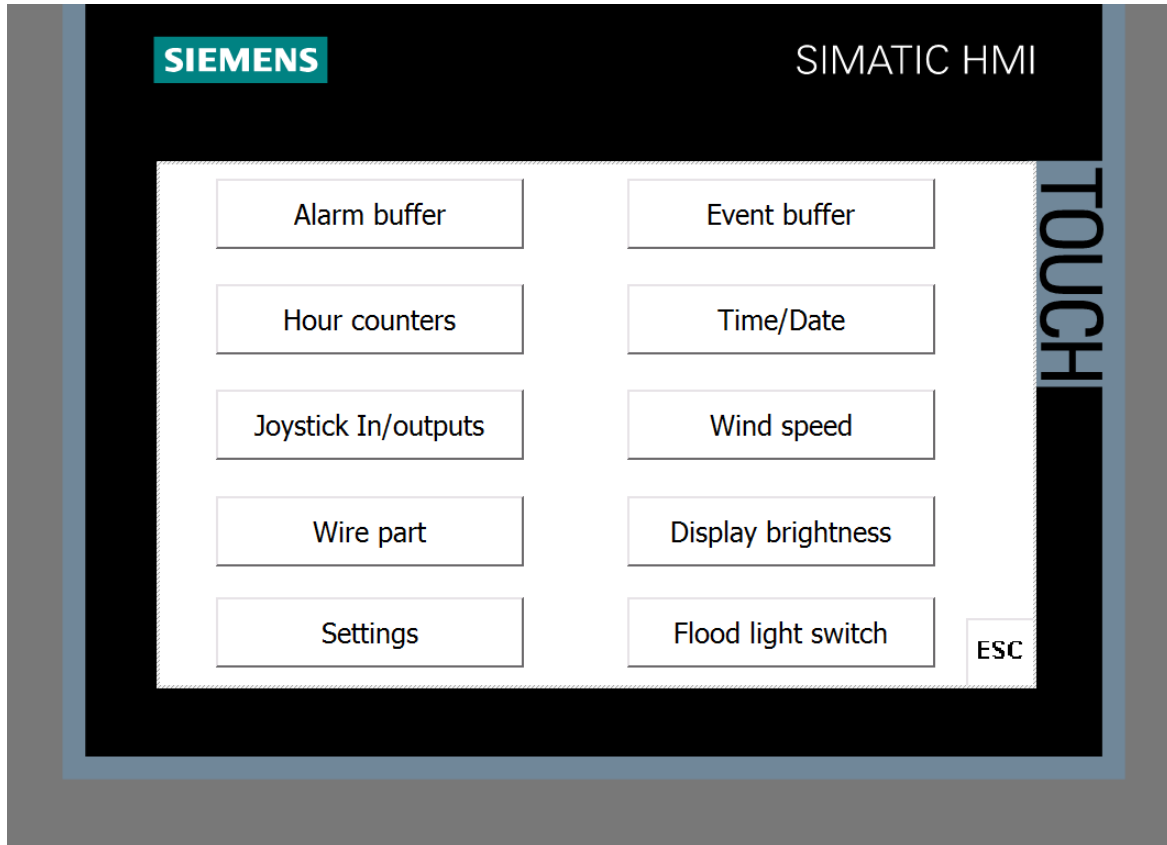
Select screen

- Press on the Settings button.

NOTE: The setting button will only be visible when the Erection key in the electrical panel is activated.

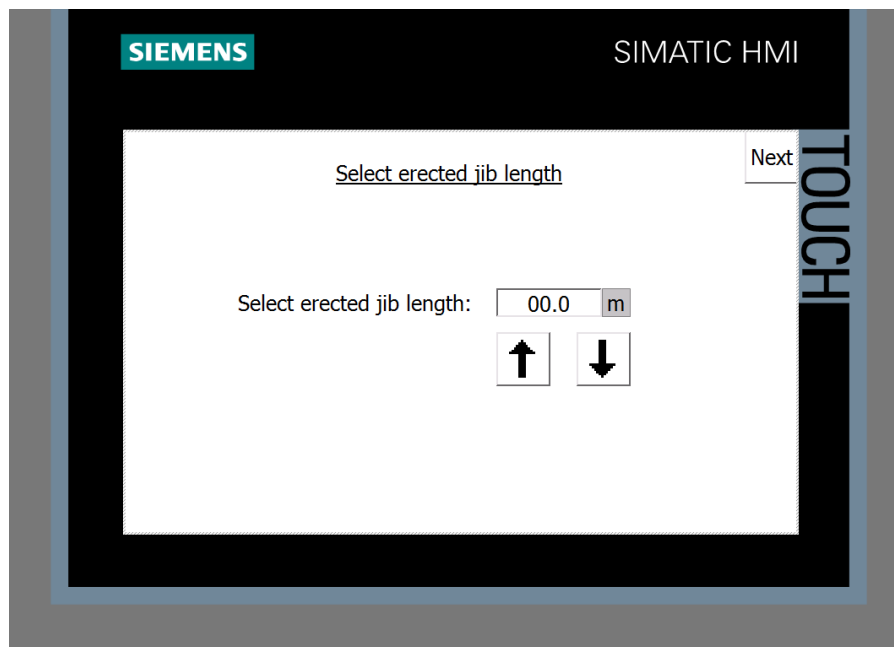
Jib selection screen

- Select erected jib length and press the “Next” button

**Note:** The jib selection is very important. This function also selects the correct load diagram for the erected jib configuration.

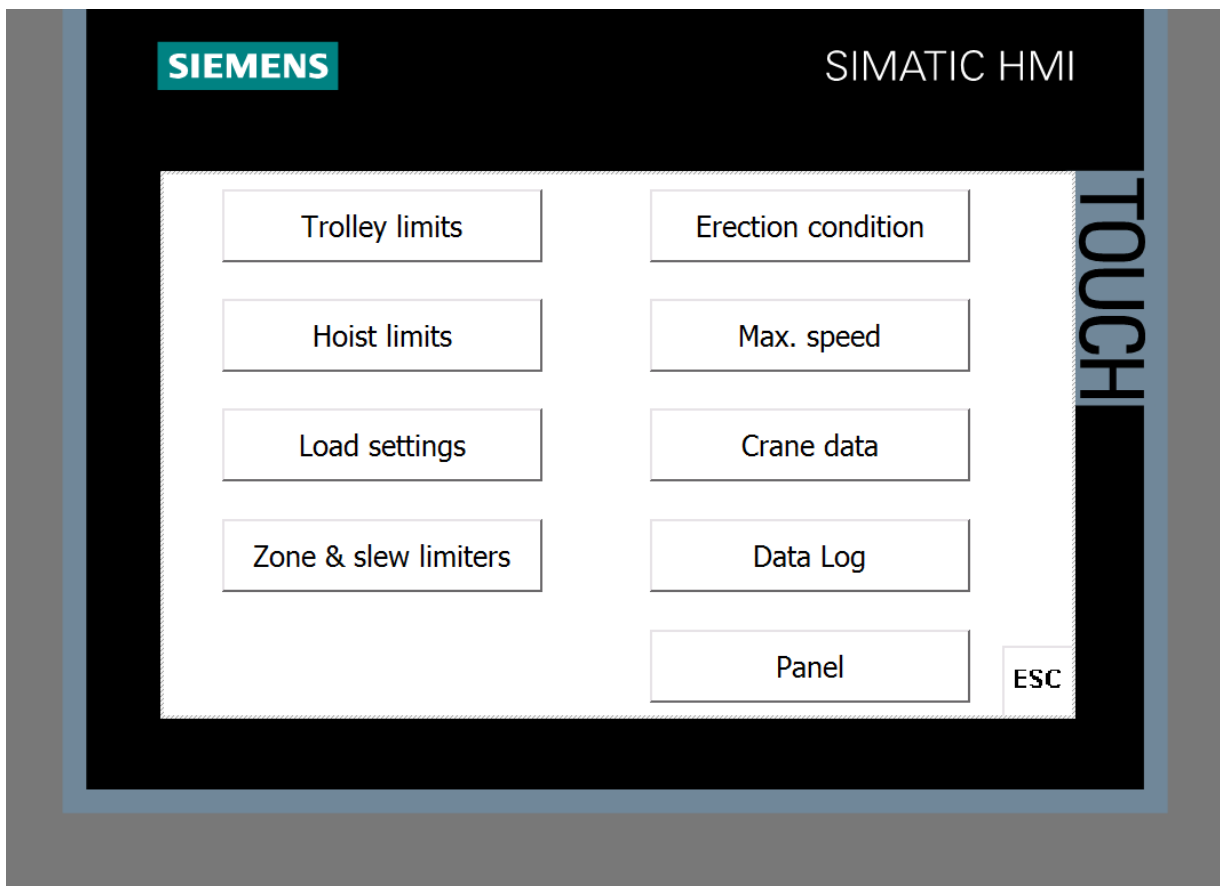
Setting screen

- To set the software hoist limit press the “Hoist limit” button on the screen under the Setting menu

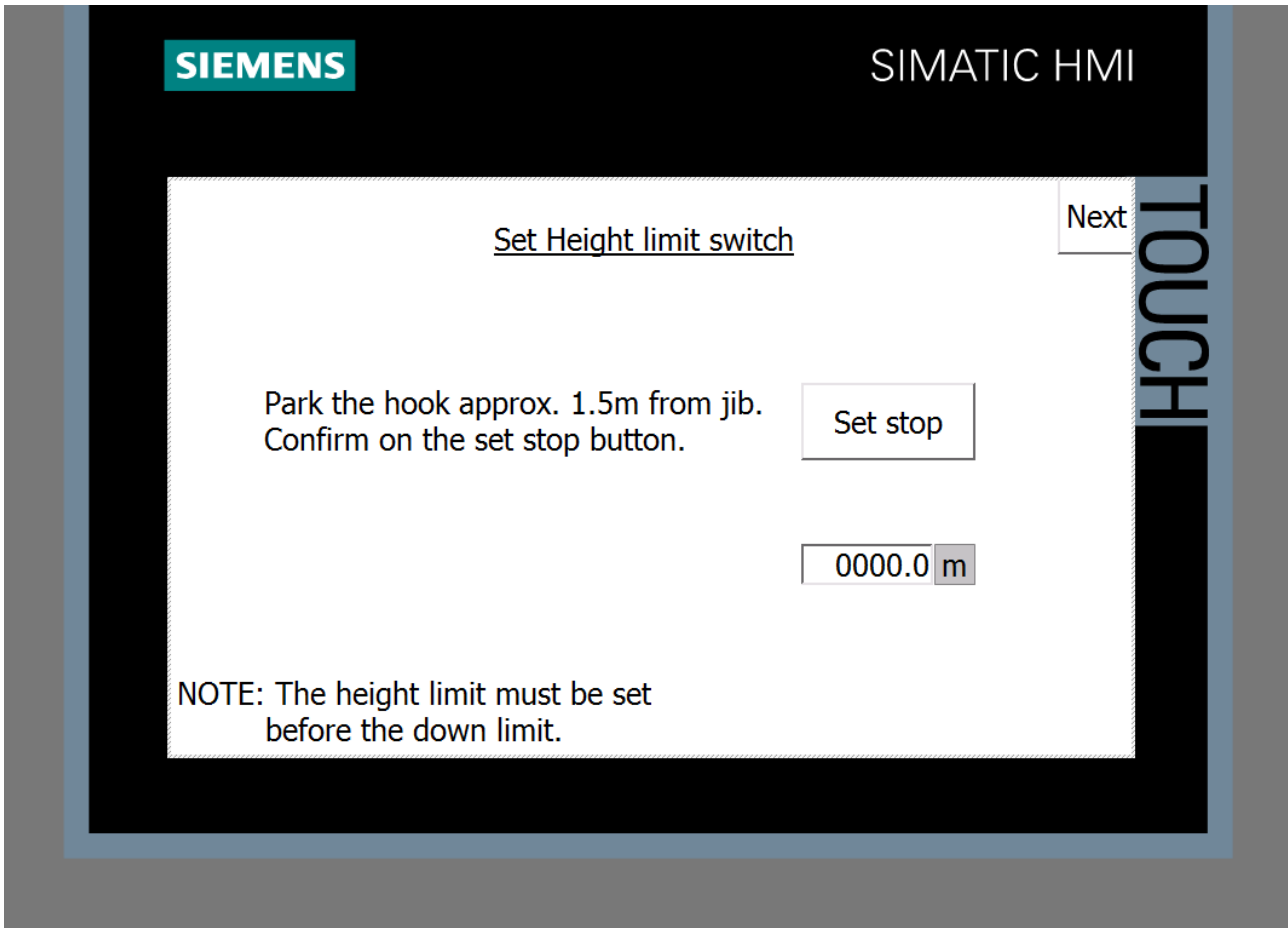
Height limit setting screen

- Move the hook down, approx. 1.5m from the boom.
- Set the software height limit at this position by pressing the “Set stop” button in the display.
- The indicator window should now read “0.0”
- Now the 1st and 2nd height limit is set

- Press the Next button and the screen for setting the depth limit appears on the display

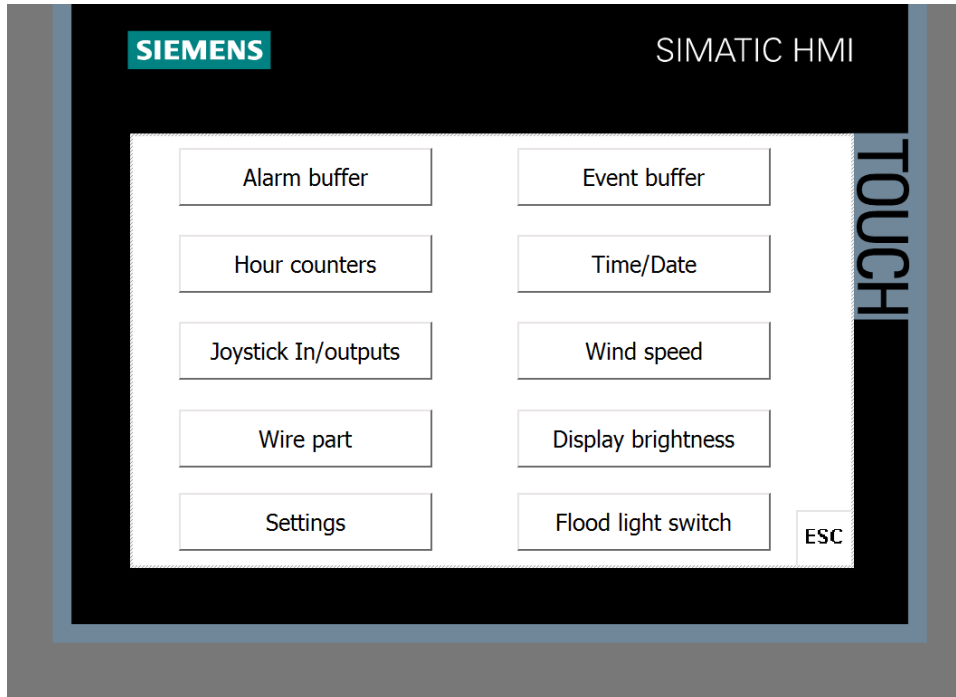
The wire part indicator in the status screen must correspond to the actual wire part the crane is operating with. If not press the “Wire part” button in the Select screen and select the correct wire part configuration. The selected wire part will be hi-lighted green in the status screen.

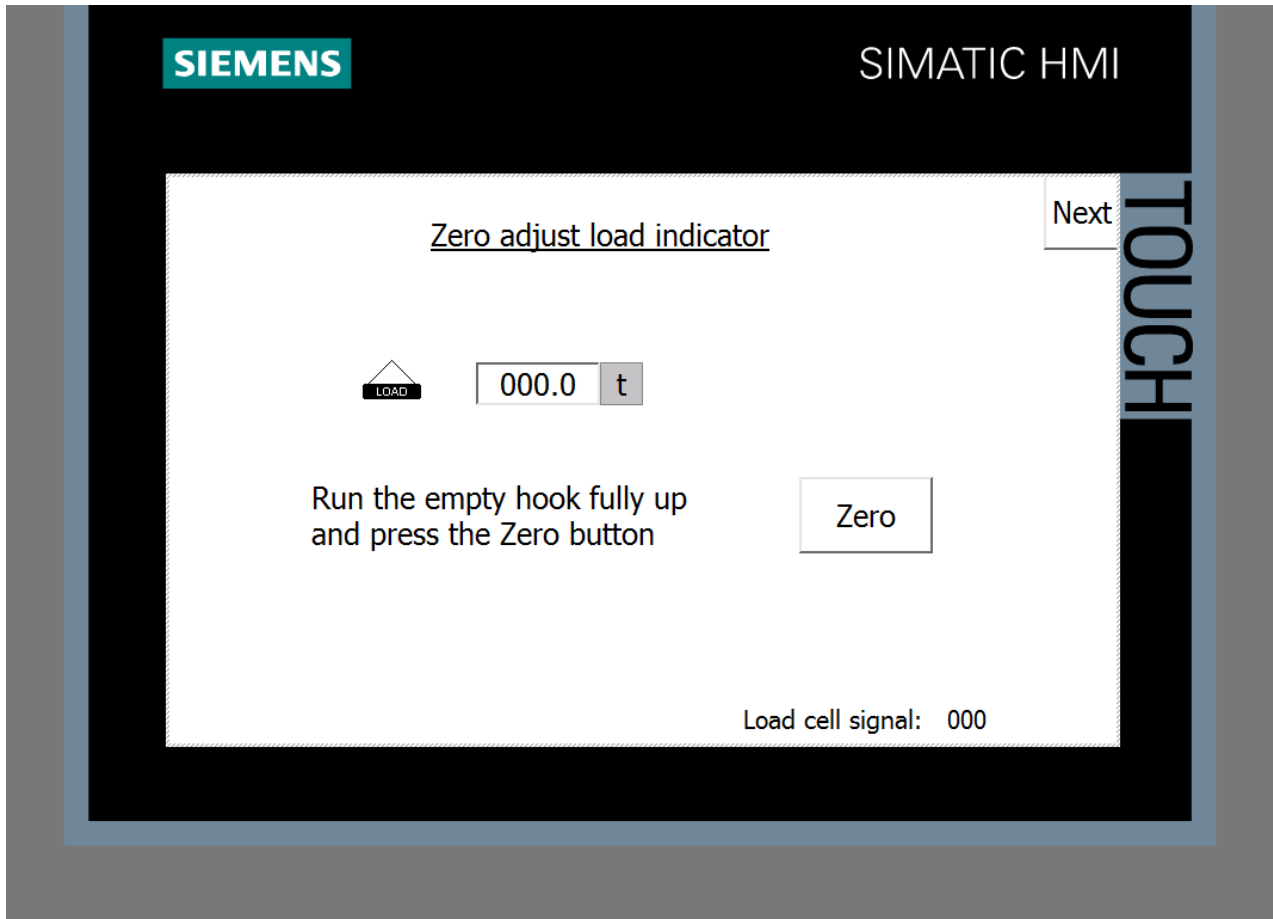
Hoist zero load setting screen

**NOTE: Remember to zero adjust the U12 load amplifier before carrying out the load setting!**

- To zero adjust the load indicator run the empty hook fully up to the height limit and press the "Zero" button. The load indicator will be reset to zero

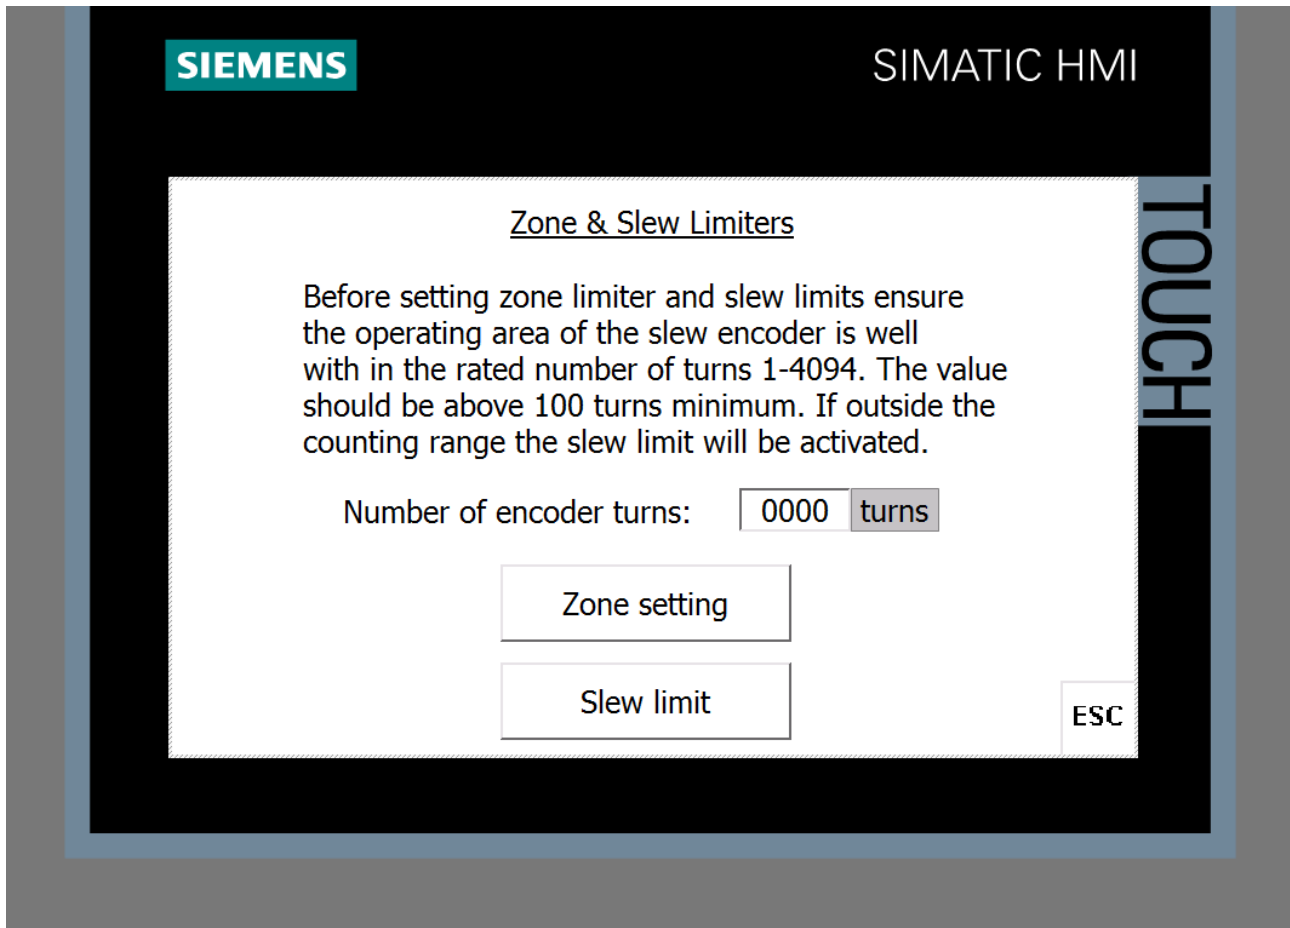
Encoder turns screen

- Press the "Slew limit" button in the screen setting screen

- Before any slew limits are set, ensure the slew encoder is within the working range. The rated number of encoder turns must be within 1 to 4094. Before doing any settings the number of encoder turns should be minimum 100. If this is not the case mechanically turn the slew encoder shaft until the number of encoder turns are above 100.
- To set slew limits press the "Slew limit" button

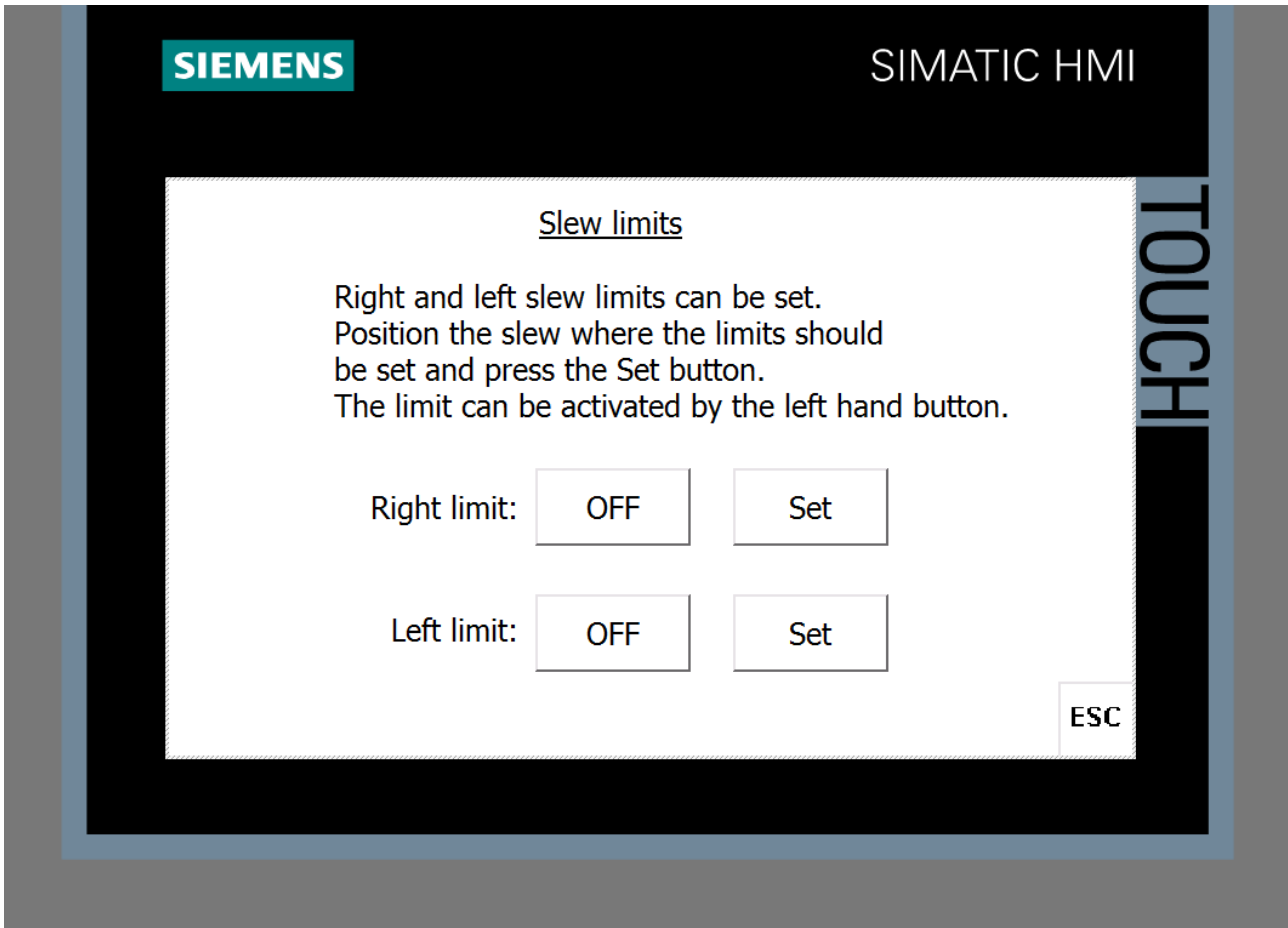
Slew limit settings

The slew limits are mostly used for main cable protection. A slew left limit and a slew right limit can be set.

- Slew the crane to the right position where the slew motion shall stop.
- Press the right limit "Set" button to set the slew right limit
- Press the right limit "OFF" button to activate the limit. The button will change to "Active"
- Press the right limit "Active" button to deactivate the limit. The button will change to "OFF"

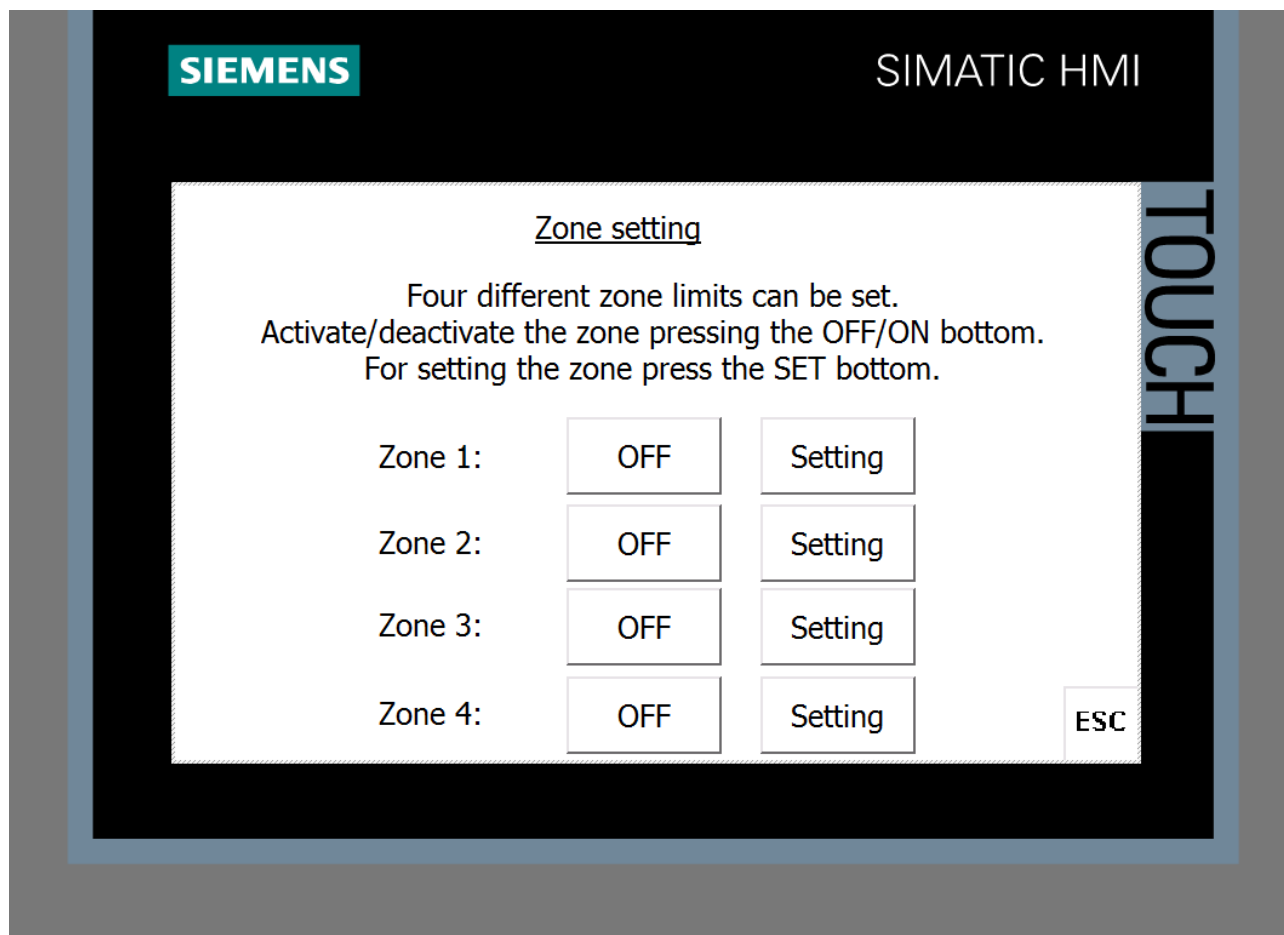
Zone setting screen

Four zone limits can be set.

Each of the four zone limits can be activated and deactivated by pressing the “OFF”/”Activated” button for each zone limits.

To set the zone limit press the “SETTING” button.

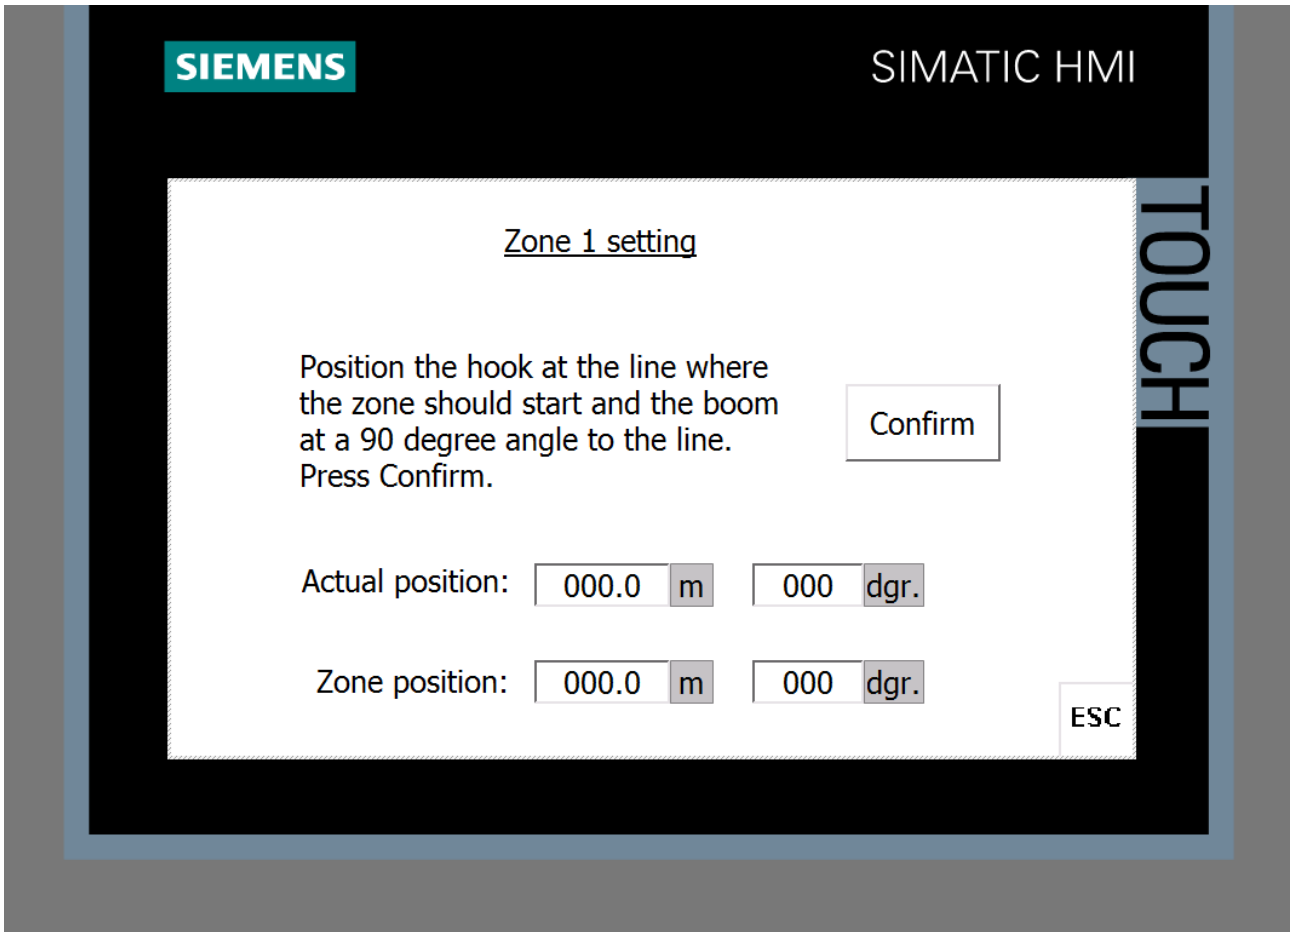
Zone 1 setting

- Place the hook at a 90 degree angle to the straight line where the zone limiter should stop the crane
- Press the “Confirm” button.

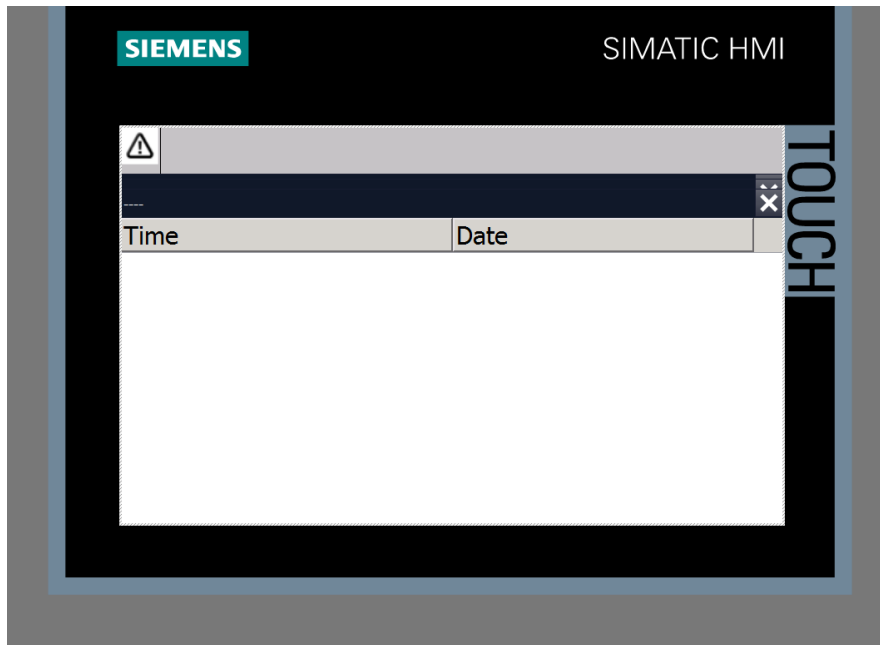
Alarm/event buffer

The last 99 alarms or events can be read in these screens. The buffers are circular logs and above 99 logs the last log will be deleted. The buffer is an internal memory bank and will be deleted, if the control system is left powerless for a longer period of time.

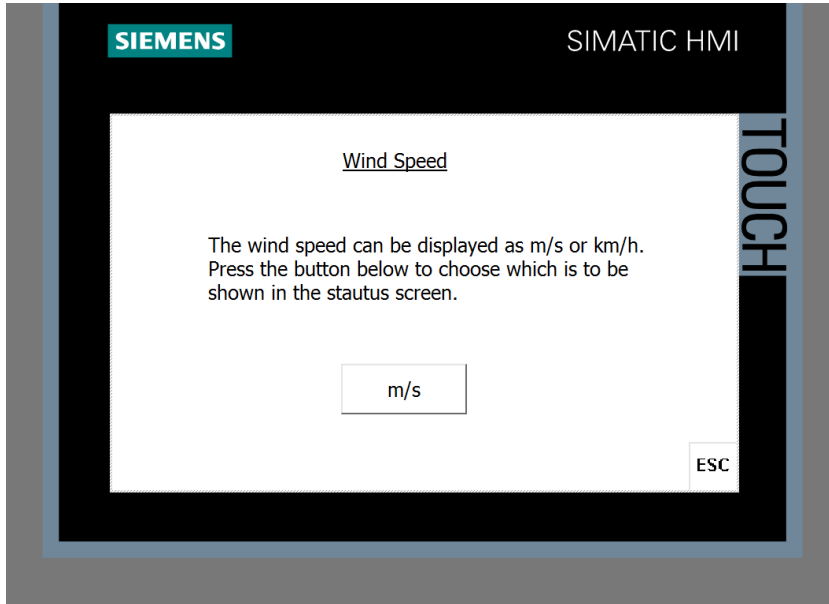
Wind speed screen

- The crane driver can choose to have the wind speed in m/s or km/h
- Press the "Wind speed" button in the select screen
- Press the button

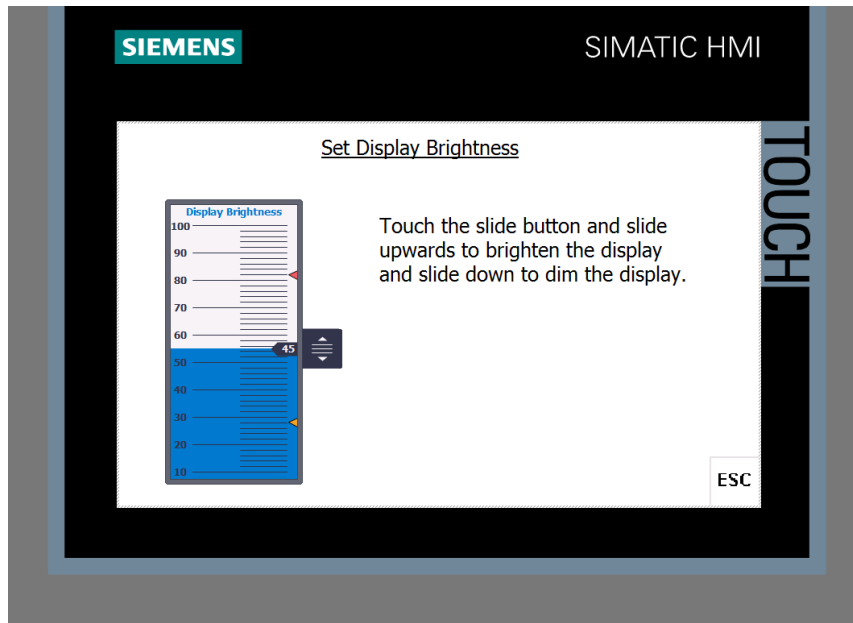
Display brightness screen

Press the display brightness button on the select screen. Touch and slide the slide button up to increase brightness and down to decrease brightness.

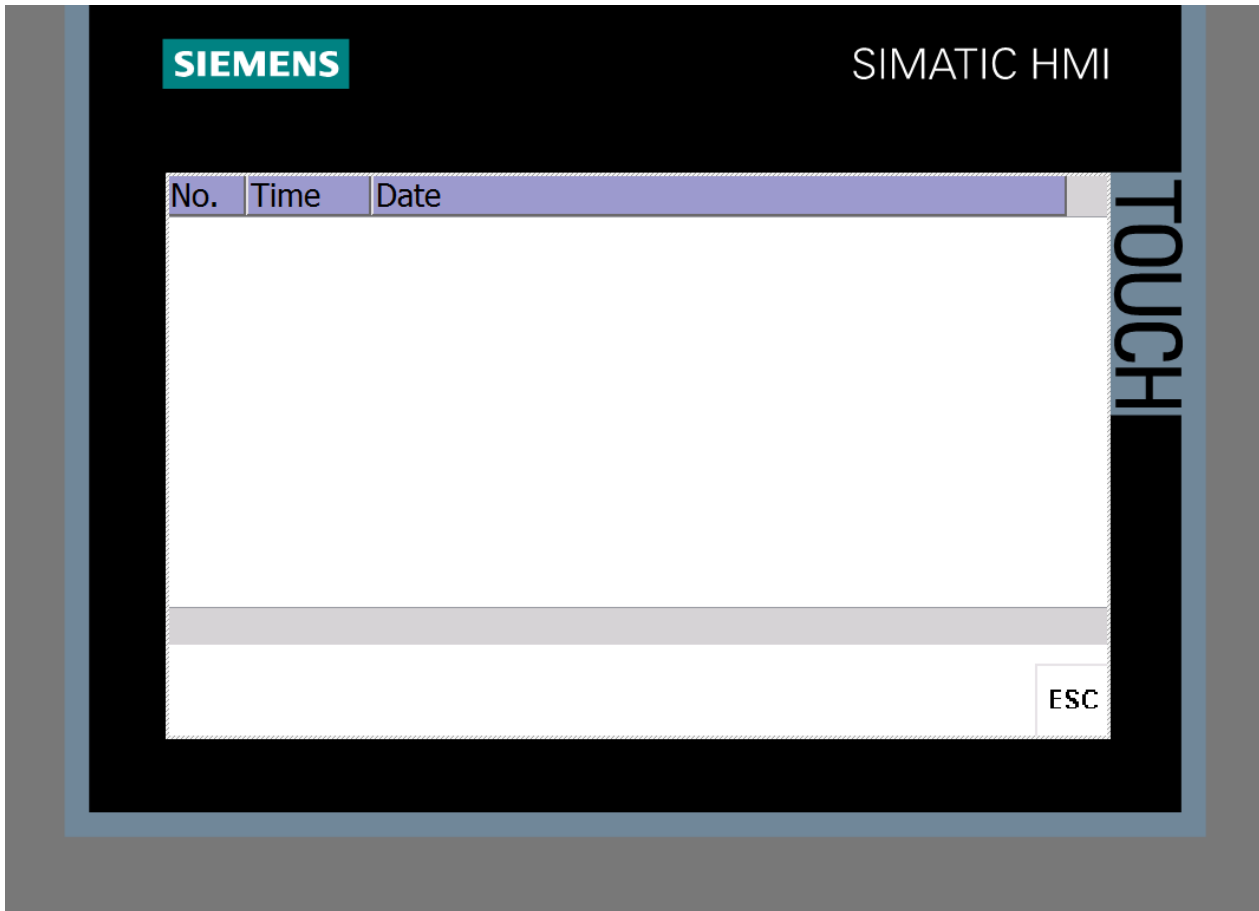
Data log screen

- **Destription:** All logs are recorded with a date and time stamp.
  - In the settings screen press the “Data Log” button
  - On the data log screen the logged data will be stored and read directly from the MMC flash memory card on the back of the panel.

Note: New logs after entering the data log screen will only be visible after leaving the data log screen and entering it again.

**Data downloading:** All logs are recorded onto the MMC flash memory card fitted into the display. The logs are saved as a Comma Separated Value (.csv) file which can be viewed via Excel. The log is a cyclic logging system and 50000 logs will be registered. The MMC flash memory card can be removed from the display and with a standard flash card reader the file can be copied to a lap top or a stationery office computer.

- Before removing the MMC memory card turn OFF the power to the display
- Remove the MMC card situated on the left-hand side of the display.
- Now either download the files on the MMC card to a lab top computer or replace the MMC card with the extra MMC card.\*
- When a MMC card has been inserted into the display turn the power back ON
- Pressing the **ESC** button will activate the previous screen

**\*Downloading the .csv file:** Utilizing a standard MMC flash card reader, copy the .csv file to a computer. After copying the file either delete or keep the file on the MMC card. If the file is kept, the logging will continue on the existing file. If the file is deleted new files will be generated when put into the display again. If 2 cards are used we recommend that all files be deleted after being downloaded.
